Emergency Response: RxR Bridge Collapse Brunswick, MO

- Owner: Norfolk Southern RxR
- Prime: Hanson Professional Services
- Sub: Prairie Engineers, P.C.

October 1, 2019 highwaters on the Grand River have formed a large log jam upstream of the RxR bridge, it's 267' long consisting of eight spans. The hydraulic forces applied on the bridge are resulting in structural deformation to the structure.

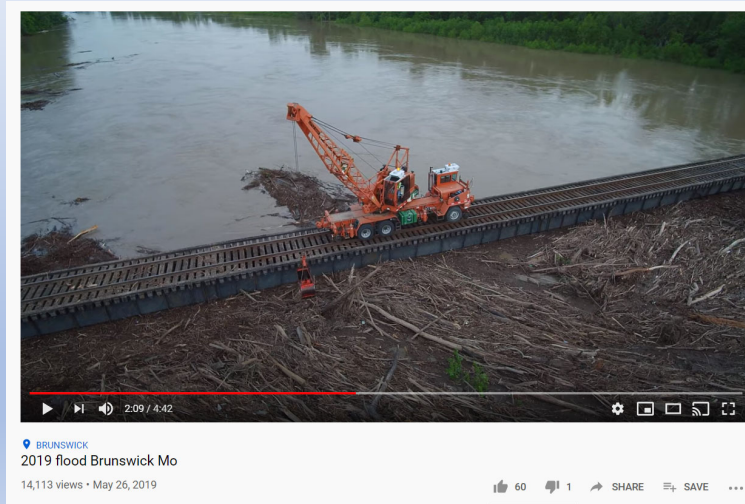
In May 2019 - spring rain events carried large amounts of timber down stream on the grand river, creating a log jam at the RxR bridge

Here is an image of the log jam in May being broken up with cranes

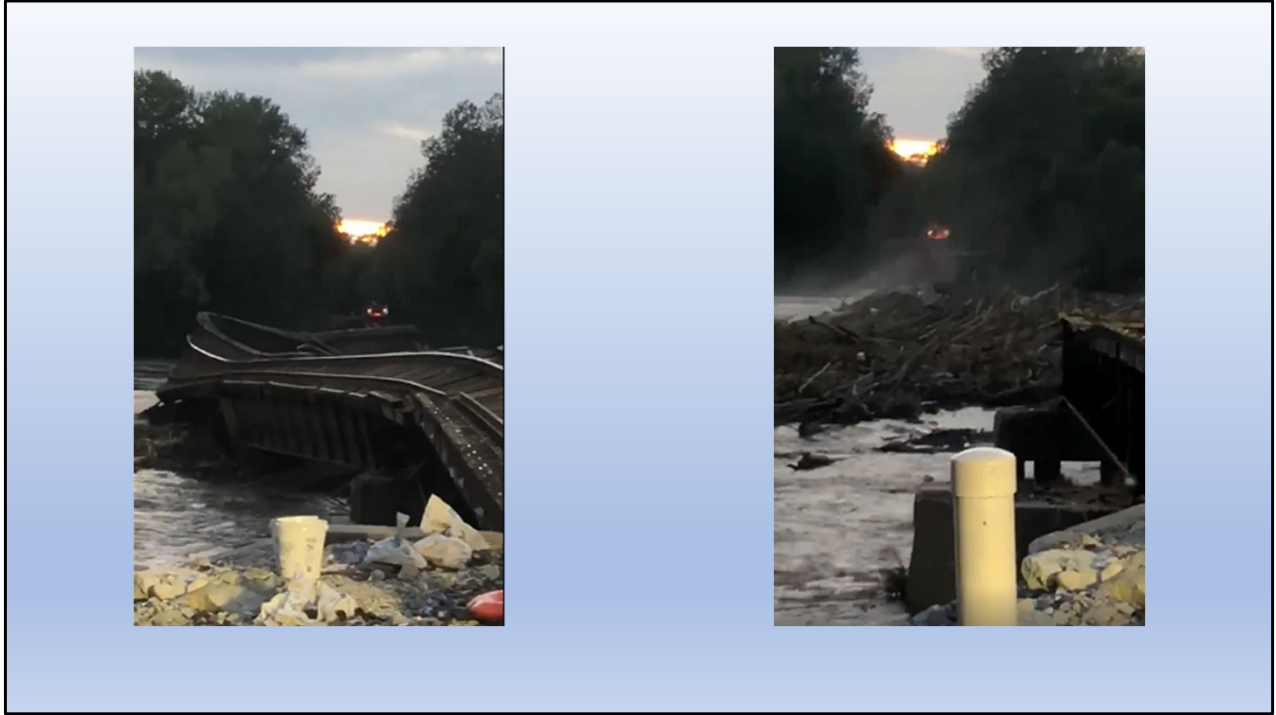
The log jam at the bridge was holding back over two feet of water, the upstream gauge on the 24 Hwy bridge recorded the rapid water level drop

Image clips from the video as the bridge fails and the log jam rushing through the opening

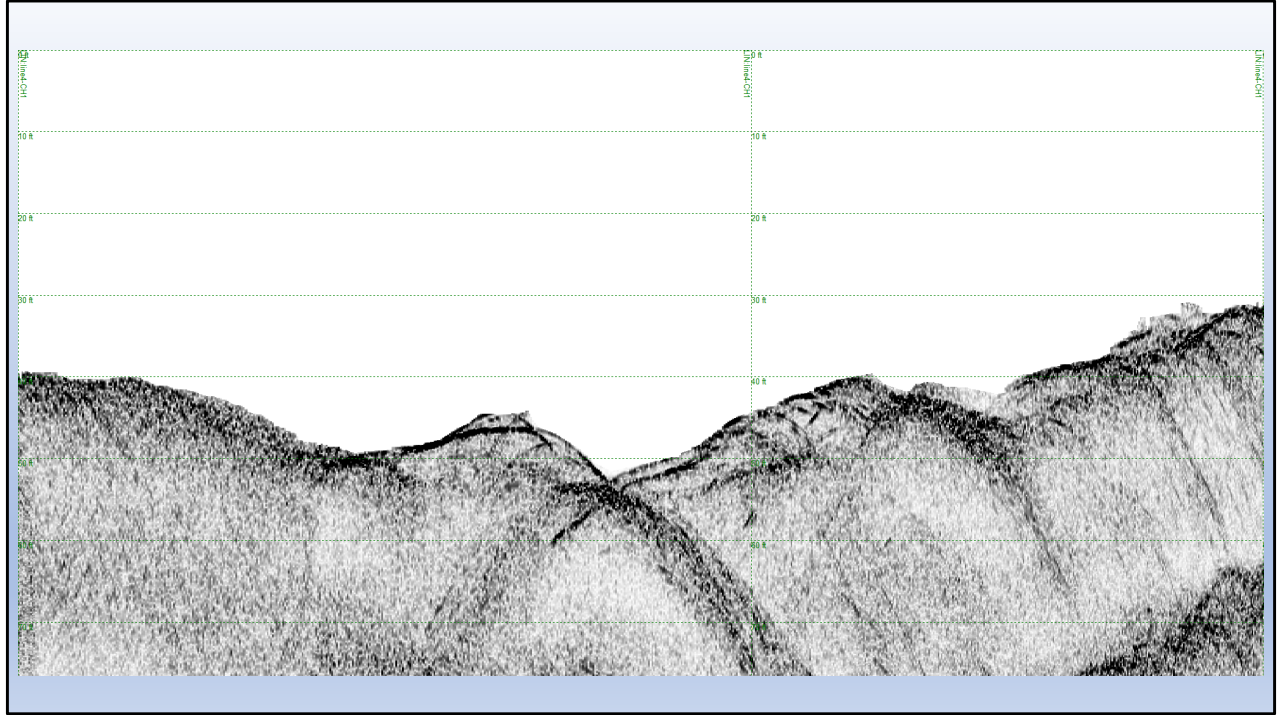
This single beam dual frequency line captured the bottom of a new scour hole over 40' deep down stream of the bridge

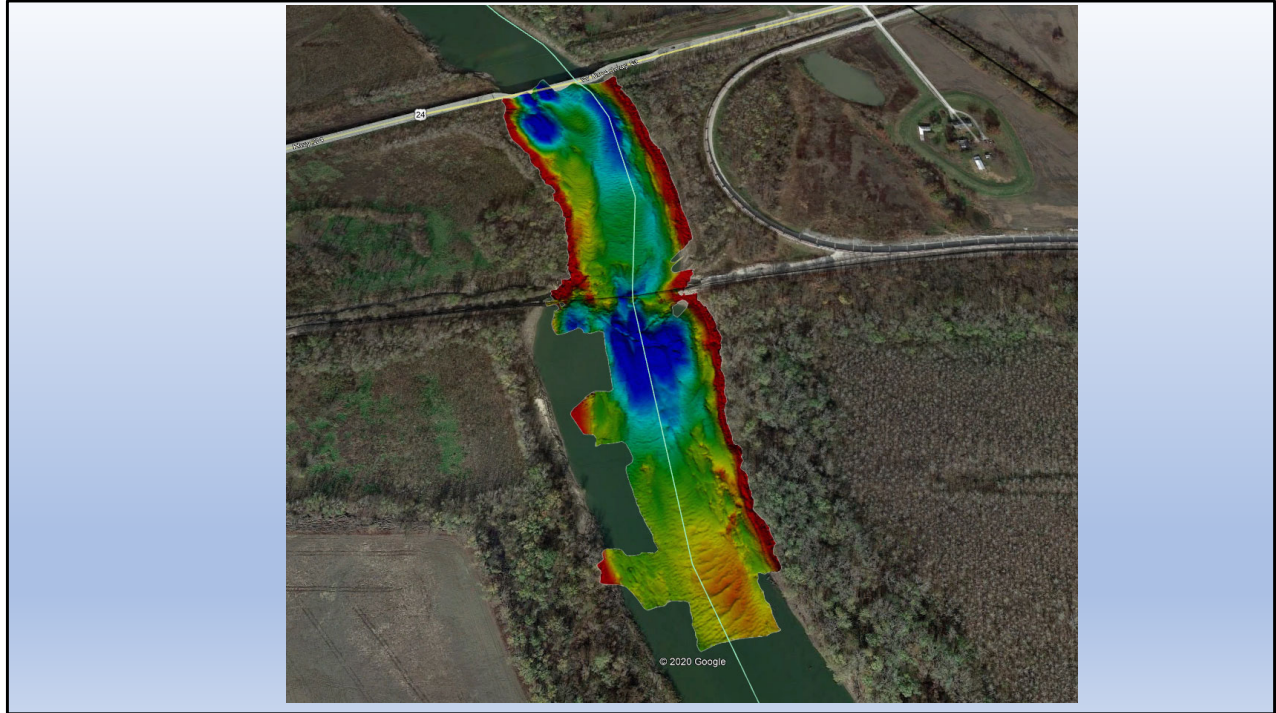
The multi beam sonar data covers a swath, or a wider area extending L & R of the vessel. Multi beam gives us a look at the full bottom surface. The dark blue areas are where the water scoured out the river bottom transporting away the soft sediment materials. You can see that the sediment was deposited further down stream in an expected wave (crest and trough) pattern.

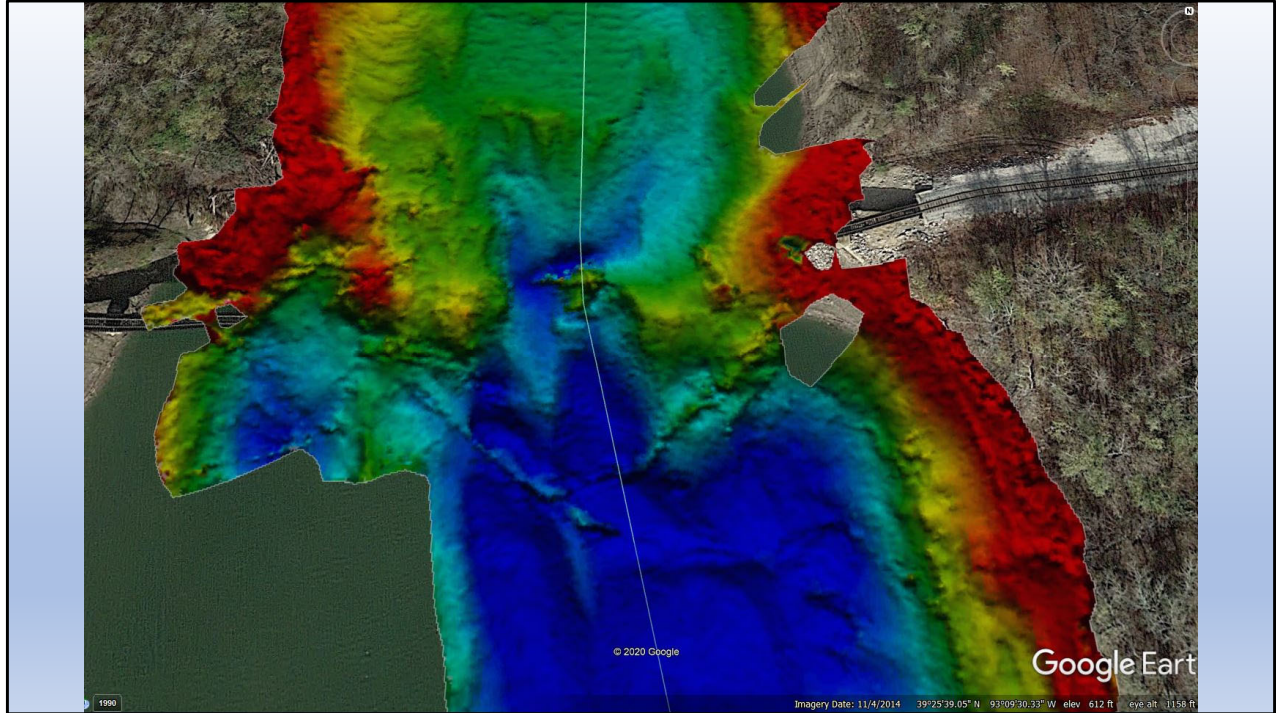
Here is a closer look at new scour hole formed when the bridge rail were cut and the water rapidly released. Note the linear features being recorded, and of note the parallel lines.

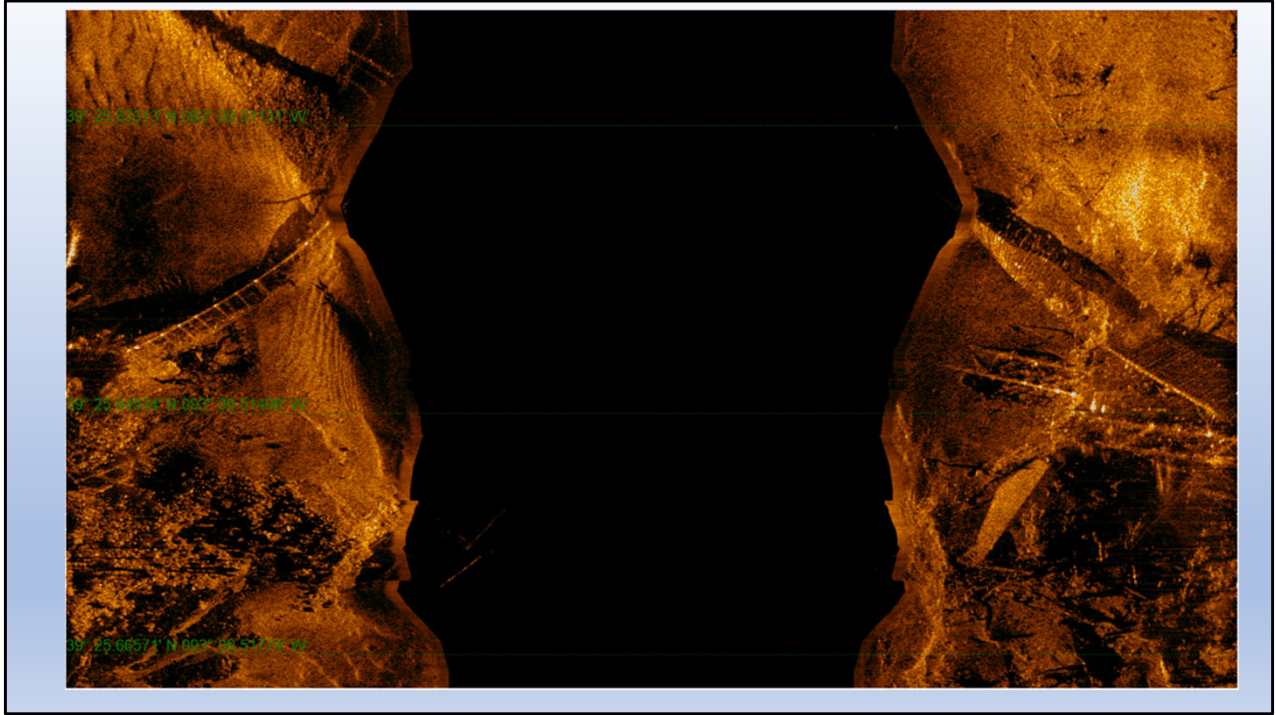
This a snip of the raw side scan image that shows the Rails, ties and steel beams that were supporting the spans, and a bridge pier

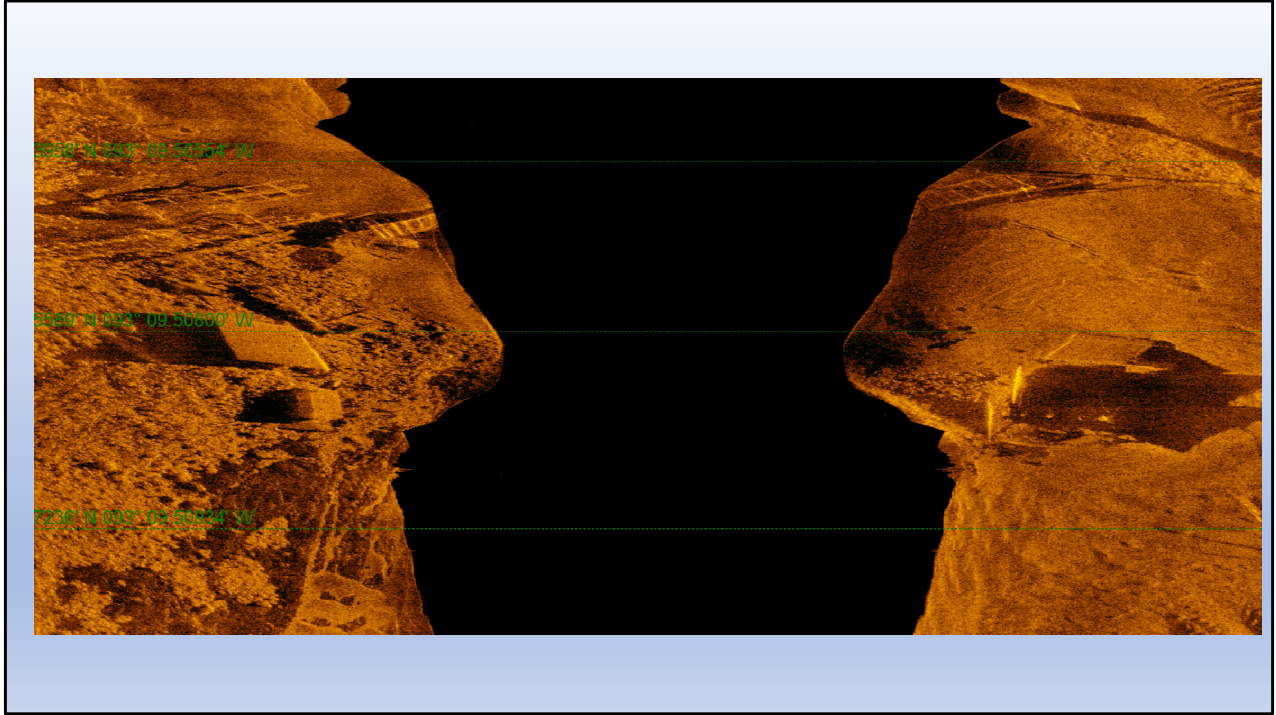
Another raw snip showing the bridge piers casting rectangular shadows

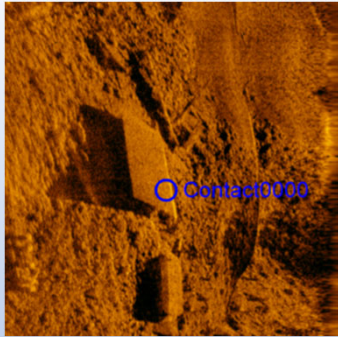
Contact0000

- Target Width: 11.68 US ft
- Target Height: 19.54 US ft
- Target Length: 24.51 US ft
- Target Shadow: 25.21 US ft

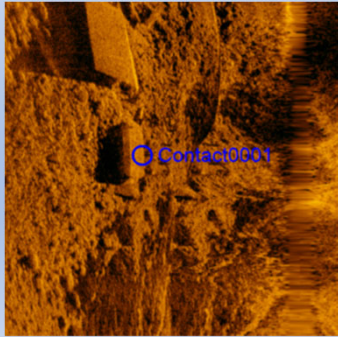
Contact0001

- Target Width: 5.66 US ft
- Target Height: 5.18 US ft
- Target Length: 16.55 US ft
- Target Shadow: 8.04 US ft
