WEBBERS FALLS RECENT PROJECTS AND SCOUR REPAIR

SAME Meeting September 18, 2025

Webbers Falls, OK.

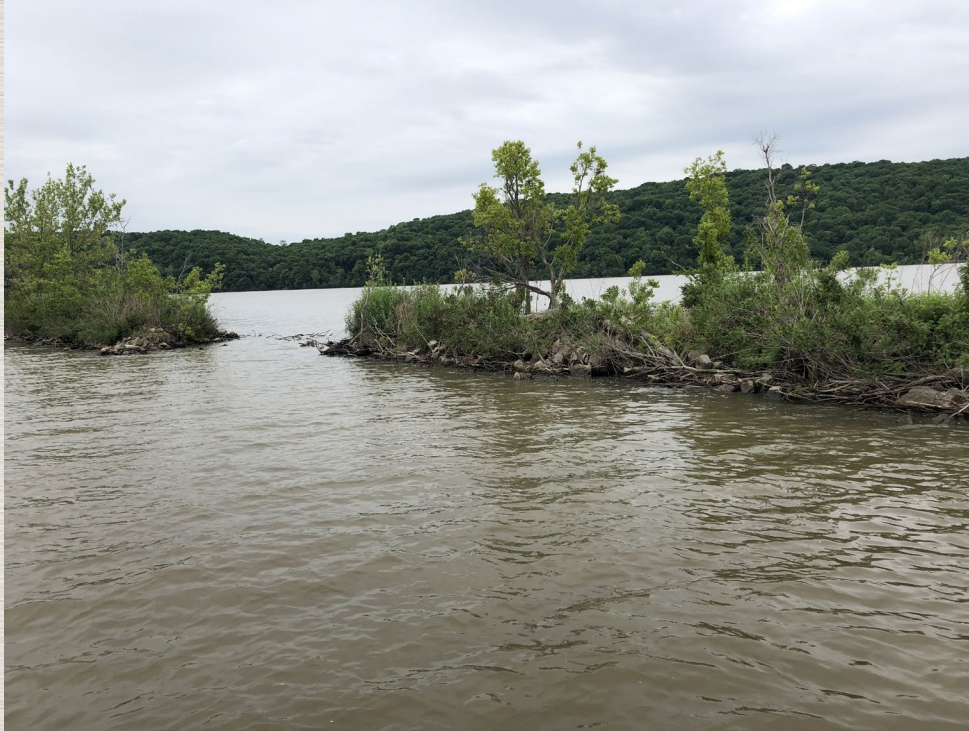
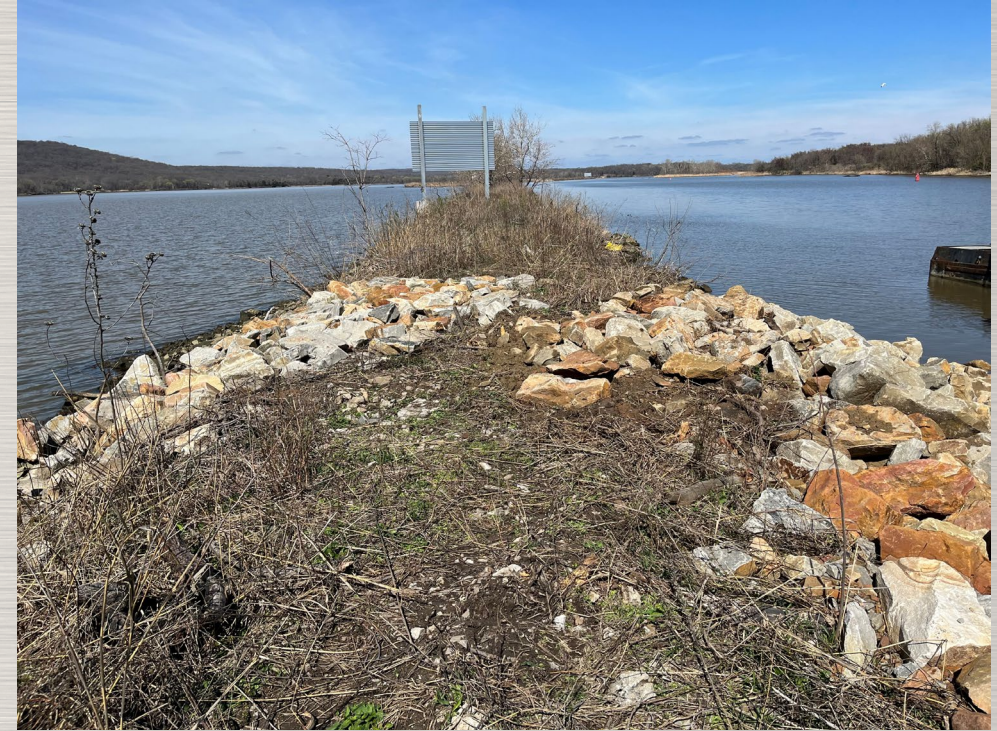
- Significant vegetative growth undermines dike cohesion
- 2019 Flood inundation resulted in dike breaches
- Historic dike degradation for elevation and cross section

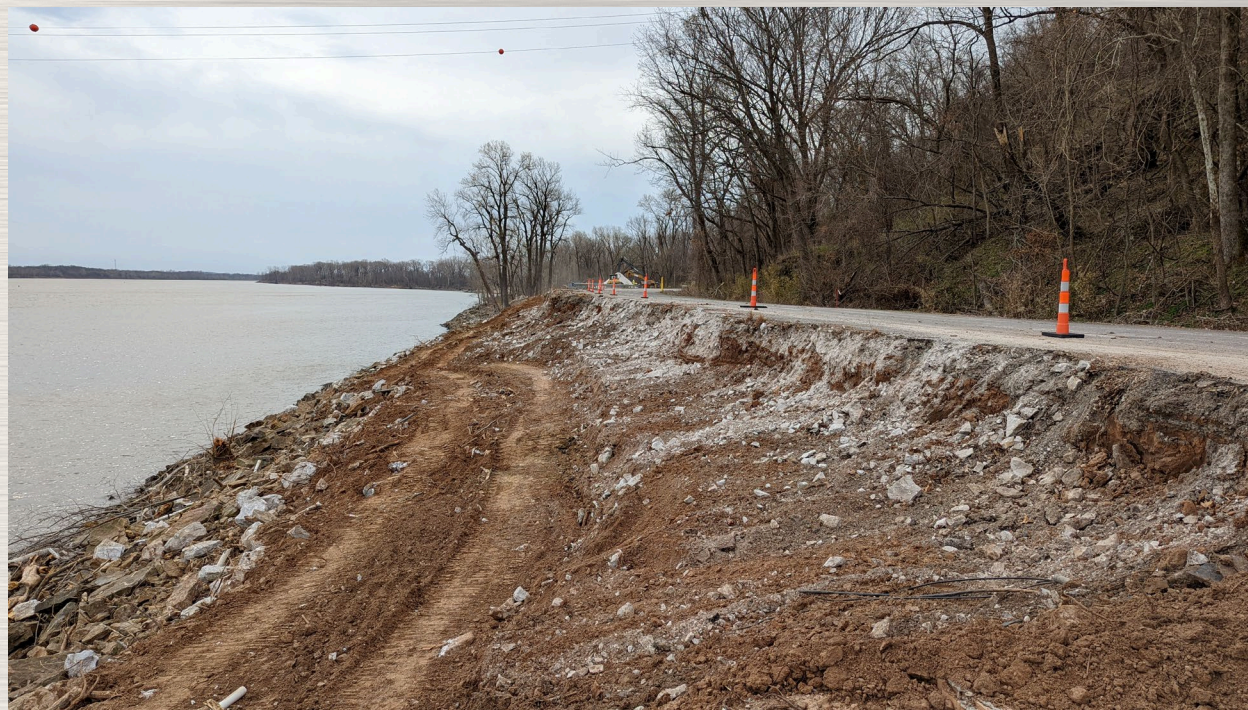
2019 Flooding in northeast Oklahoma and southeast Kansas resulted in significant flows which degraded the channel banks

Existing riprap and subgrade was washed downstream, significant damage to powerhouse access road

Remove and replace damaged guardrail and fencing

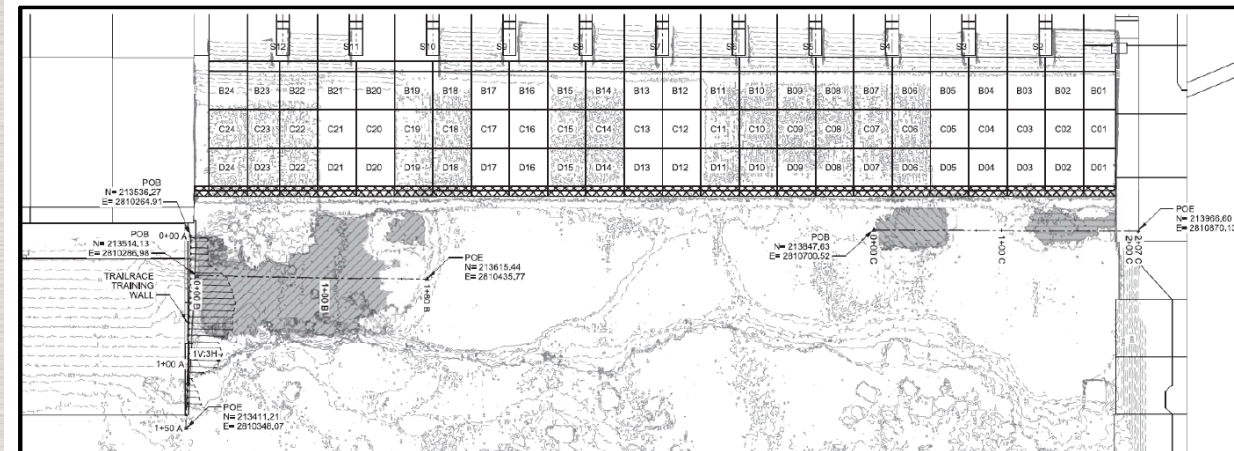
Figure 1: Scour Repair Areas (Webber Falls L&D 16 Downstream Scour Engineering Evaluation Report, INDC 2015)

- Webbers Falls Lock and Dam has historically had scour noted immediately downstream of the spillway (since 1974)
- SWT utilized services of the USACE Inland Navigation Design Center to evaluate stability of structures based on scour and provide recommendations for scour countermeasures in 2015.
- No instabilities were found however, the INDC recommended to address the scour holes by filling them with unreinforced unanchored underwater concrete (1,778 CY)
- SWT utilized Mead&Hunt to develop plans and specifications to address the scour holes; however, they proposed a much bigger area of concrete (15,000 CY) in 2019 at an est. cost of \$8M
- Record pool event in May 2019 which increased scour

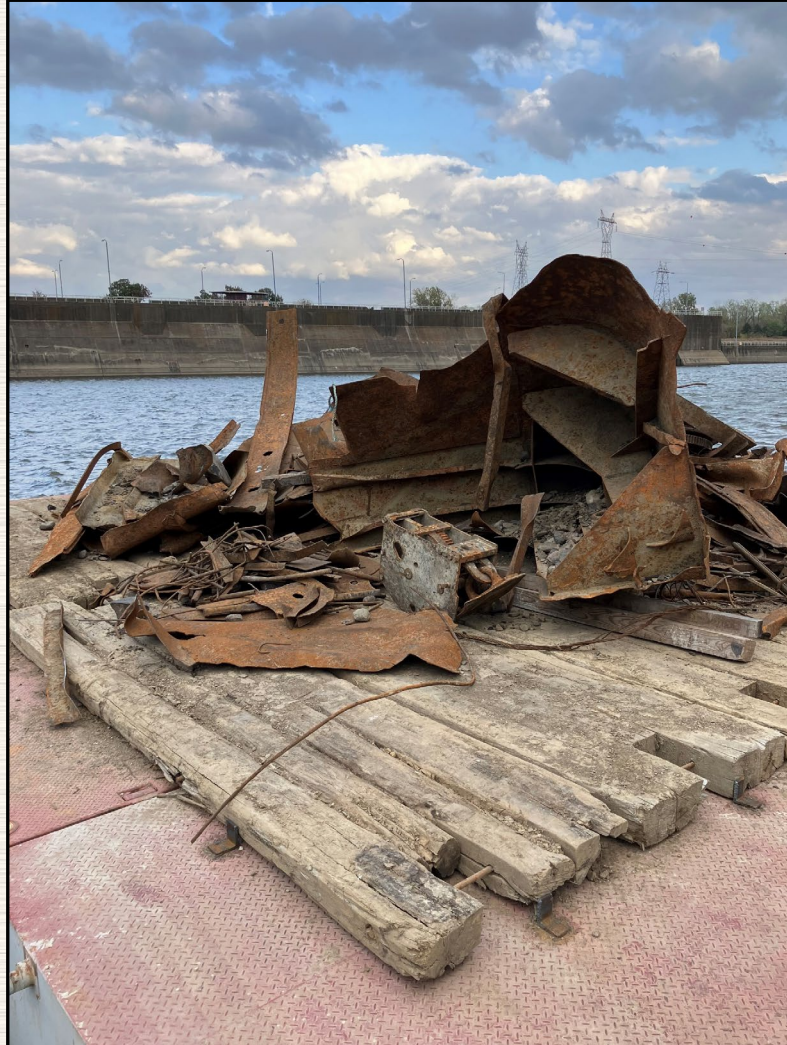
Existing Debris Removed from Scour

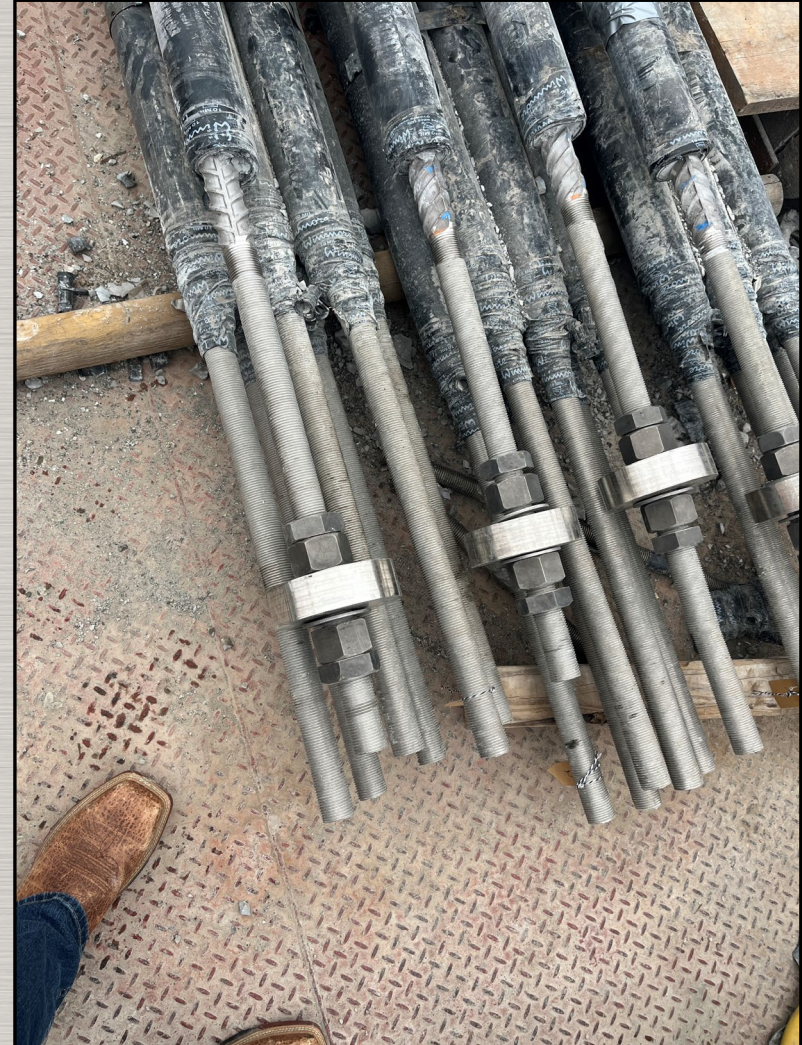
New Rock Dowel Anchors

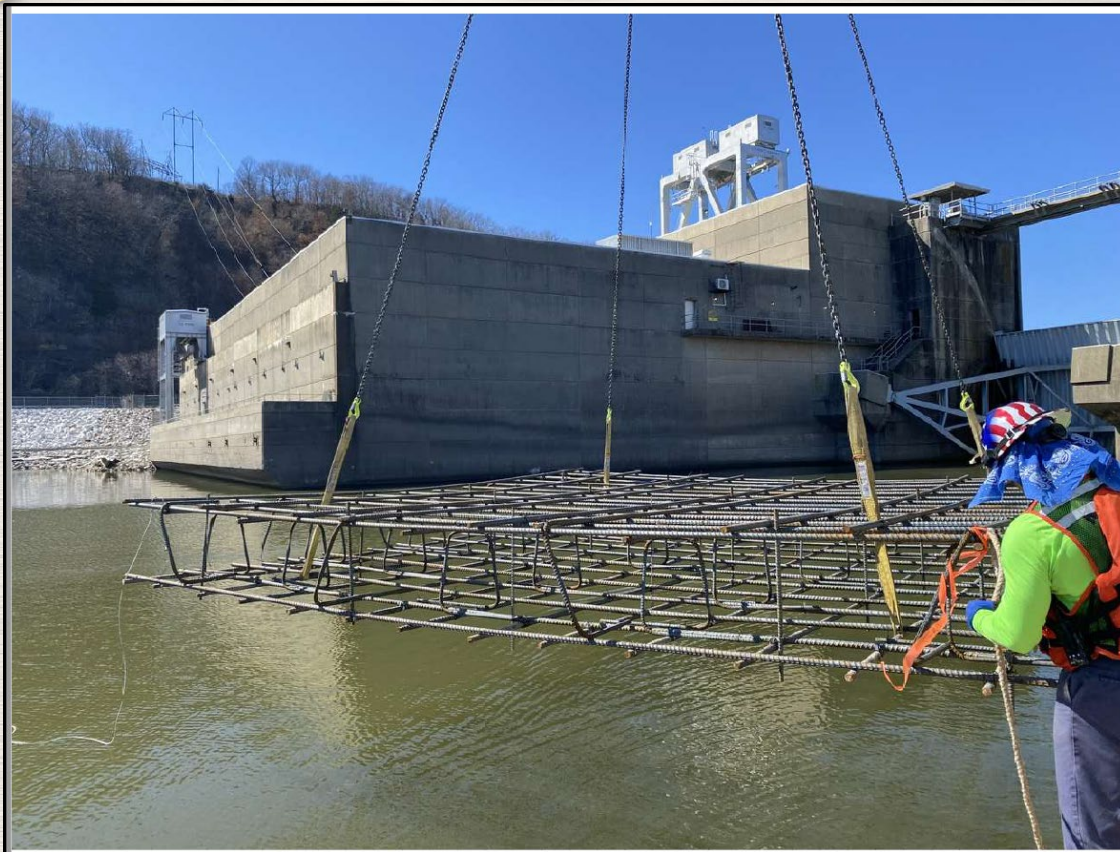
New Lift 1 Reinforcing Cage Tied to
Rock Dowel Anchors

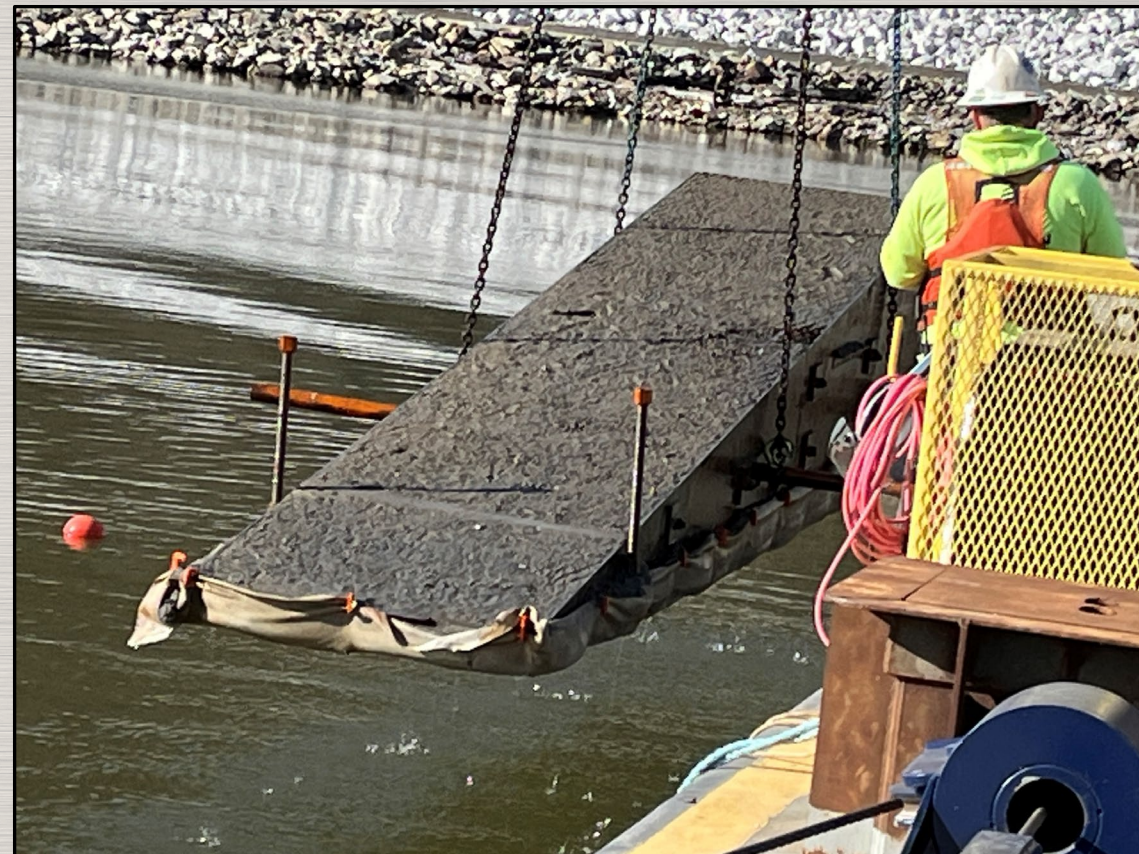
New Lift 2 Custom Sloped Formwork,
Transition from Wall
