Jefferson Barracks Building 29

Jefferson
Barracks
Building 29

David Cockrum

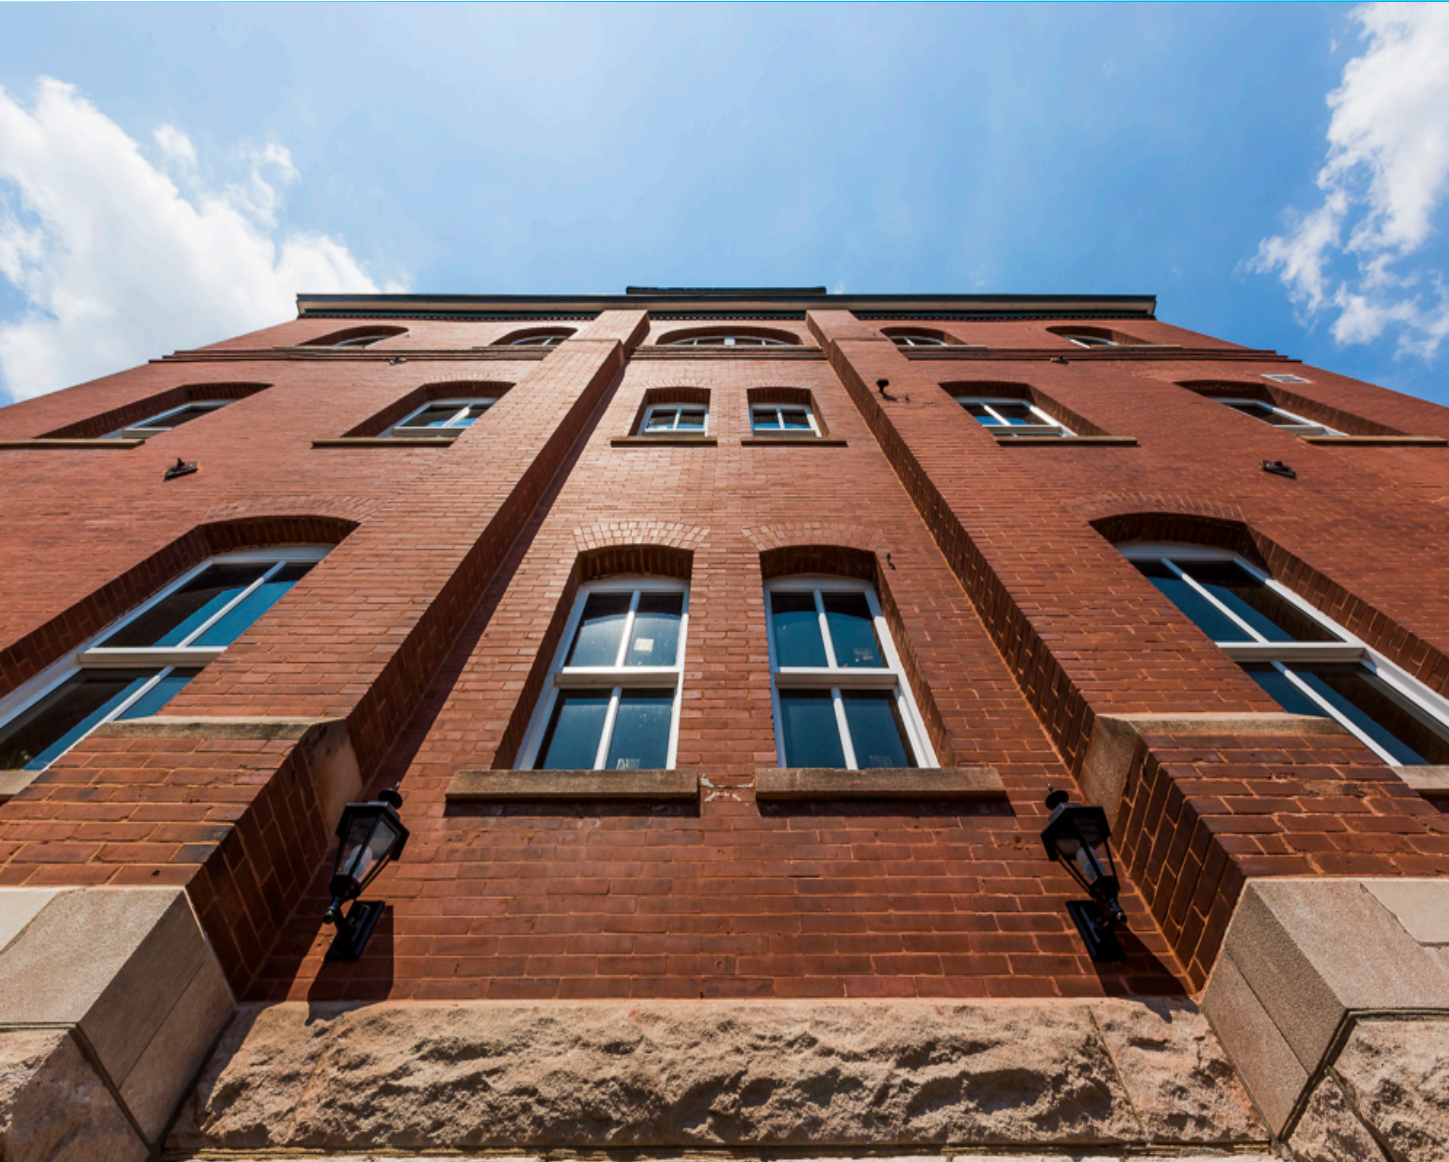
- 3 and 4 wythe brick
- Massive construction
- Majestic

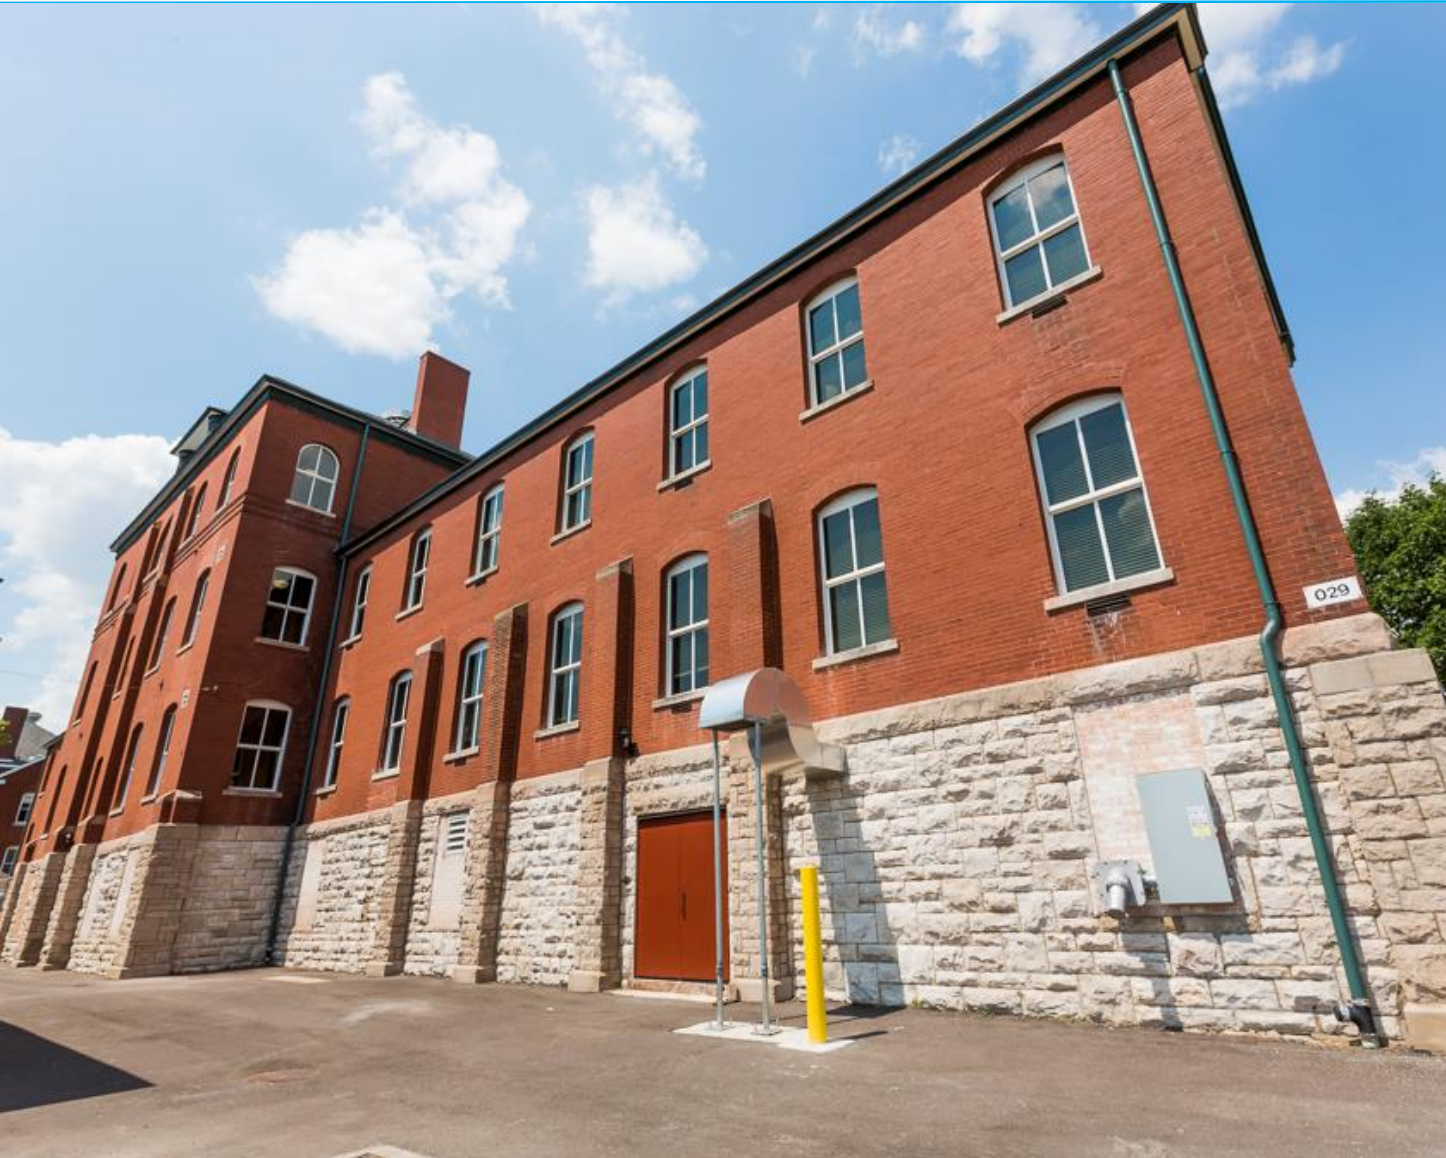
- Limestone watertable
- Limestone foundation walls
- Arched windows
- Chimneys
- Pilasters

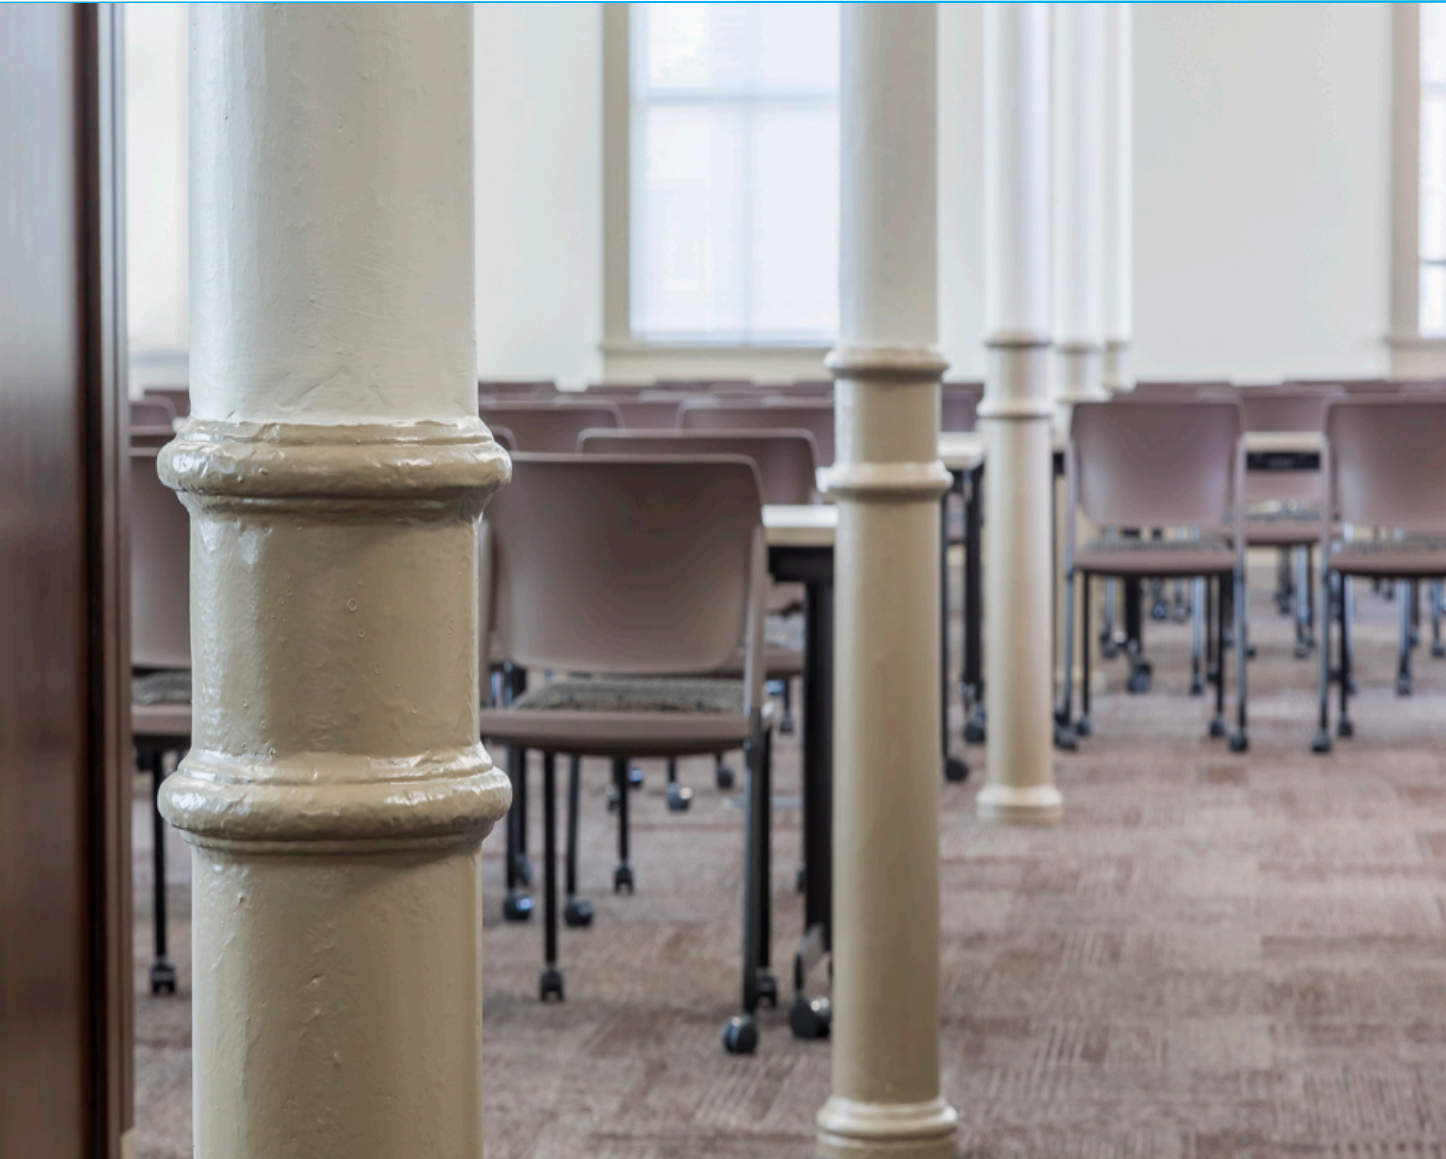
- Cast-iron columns
 - Weak in shear and tension
 - Good in compression

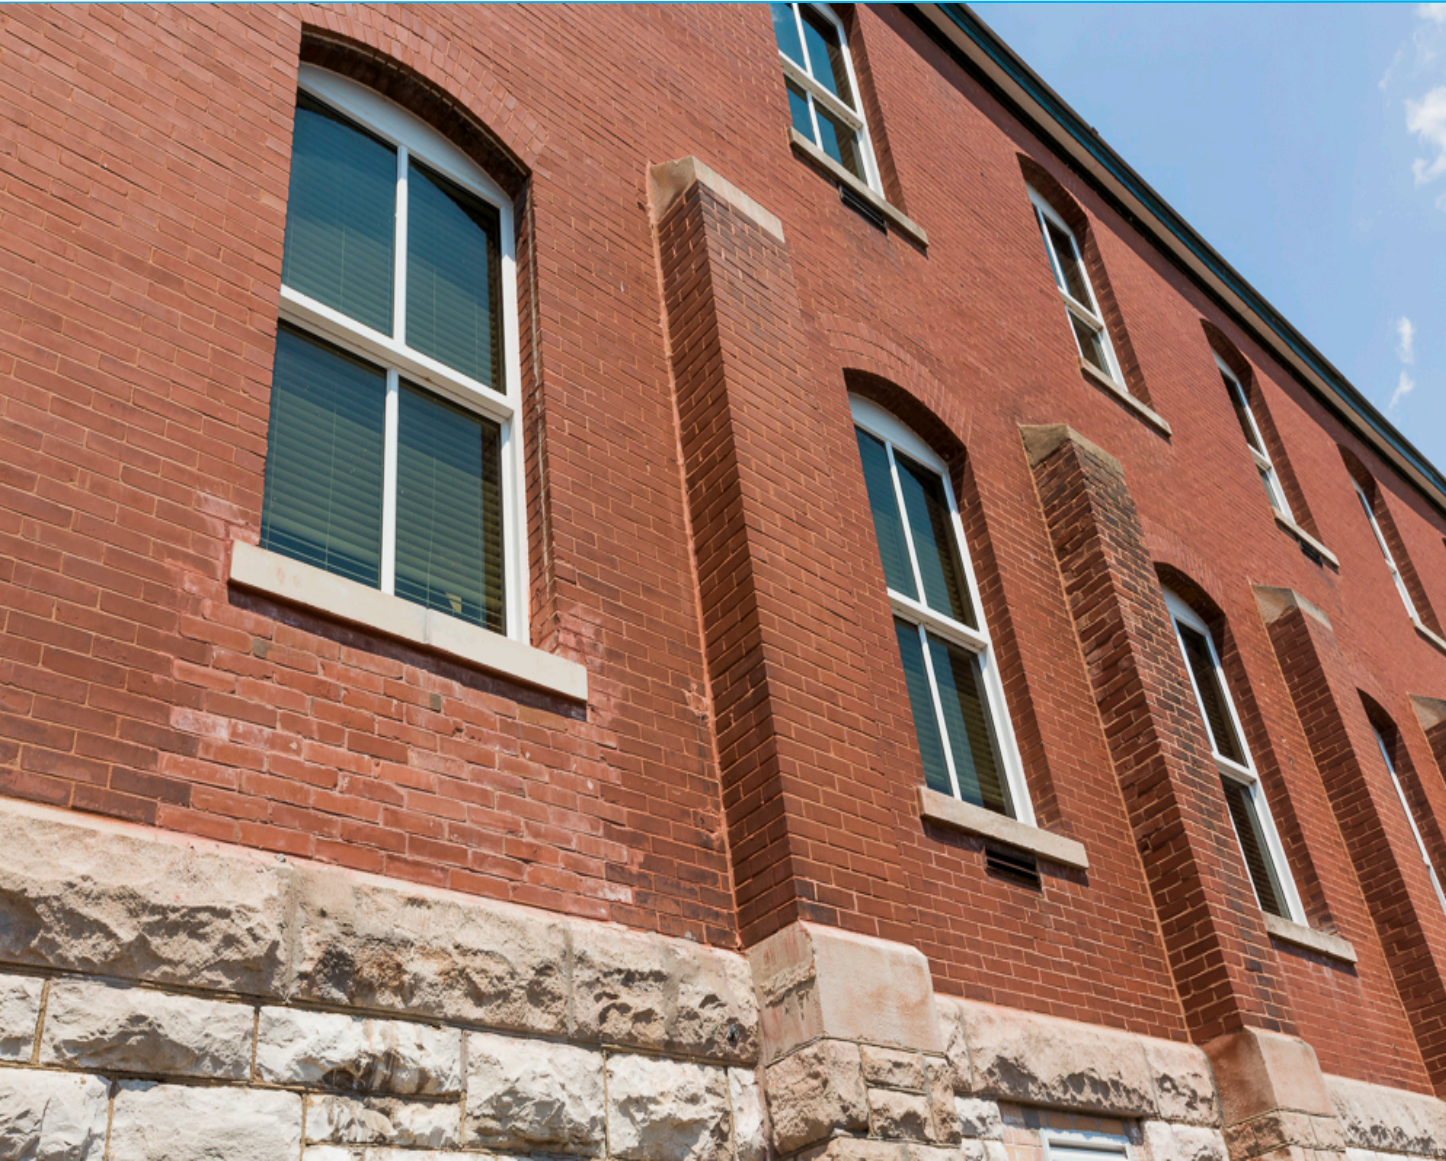
- Arched windows
- Custom blast connection at top for ATRP windows

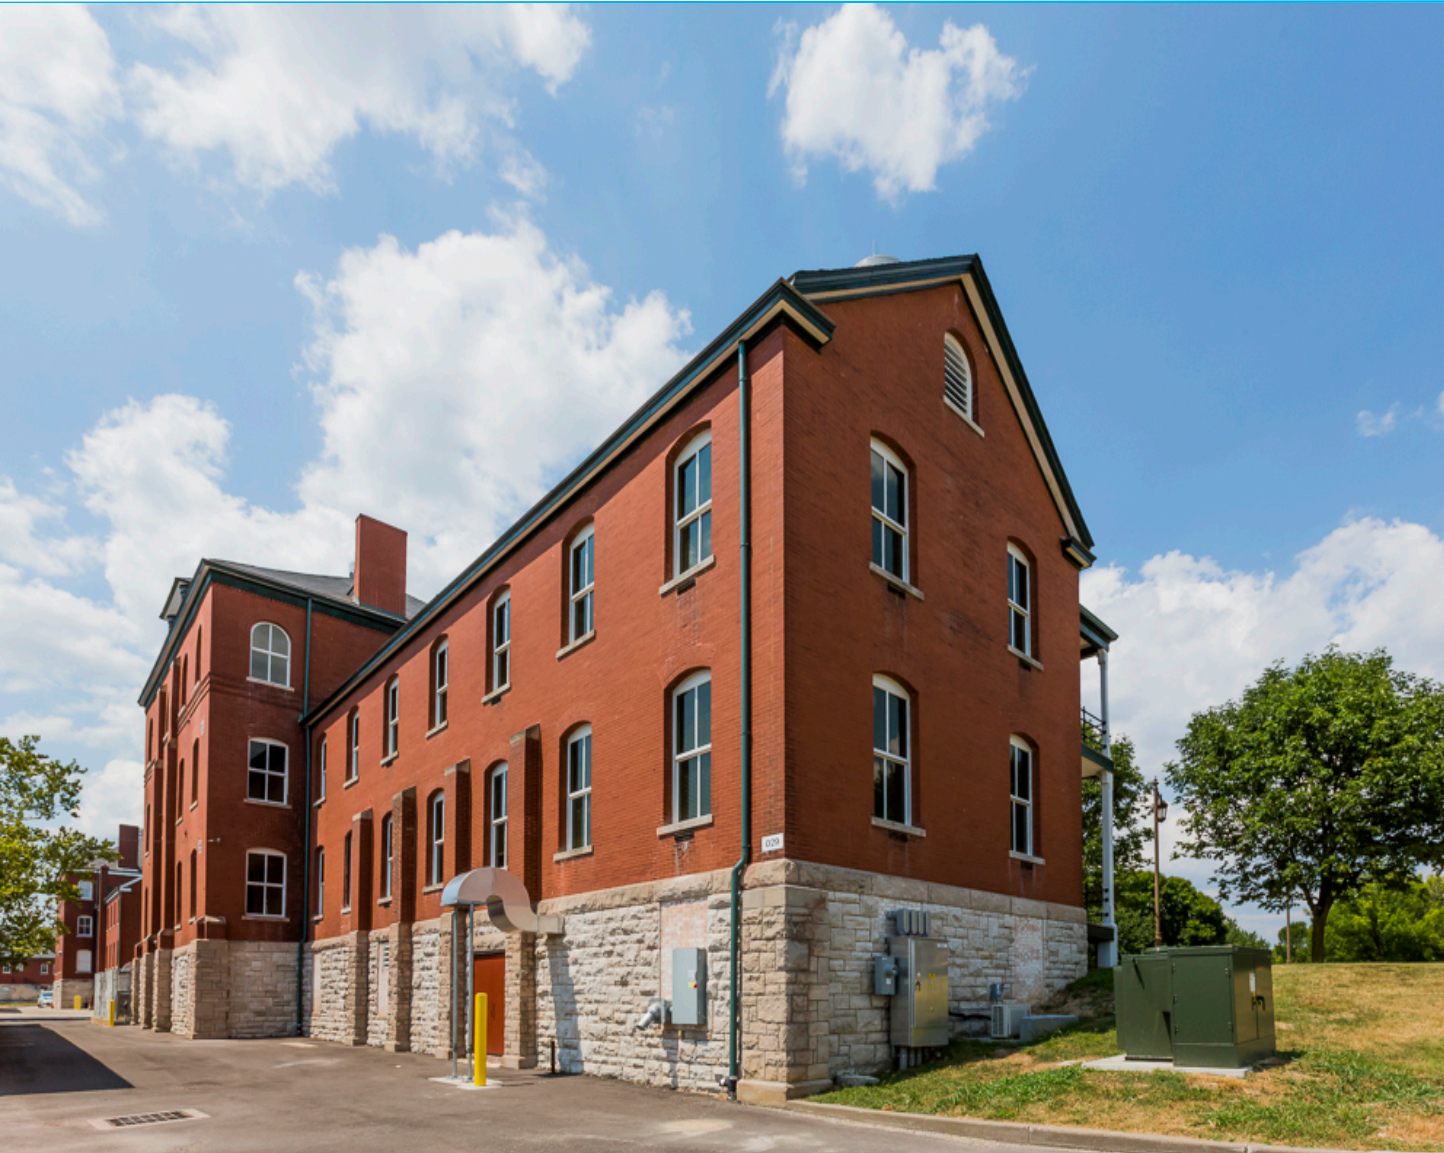
ATFP - Triggers

- Three stories in front, four on back; progressive collapse required
- What is a story?
 - Human occupancy
 - Egress
 - Lights
 - ventilation

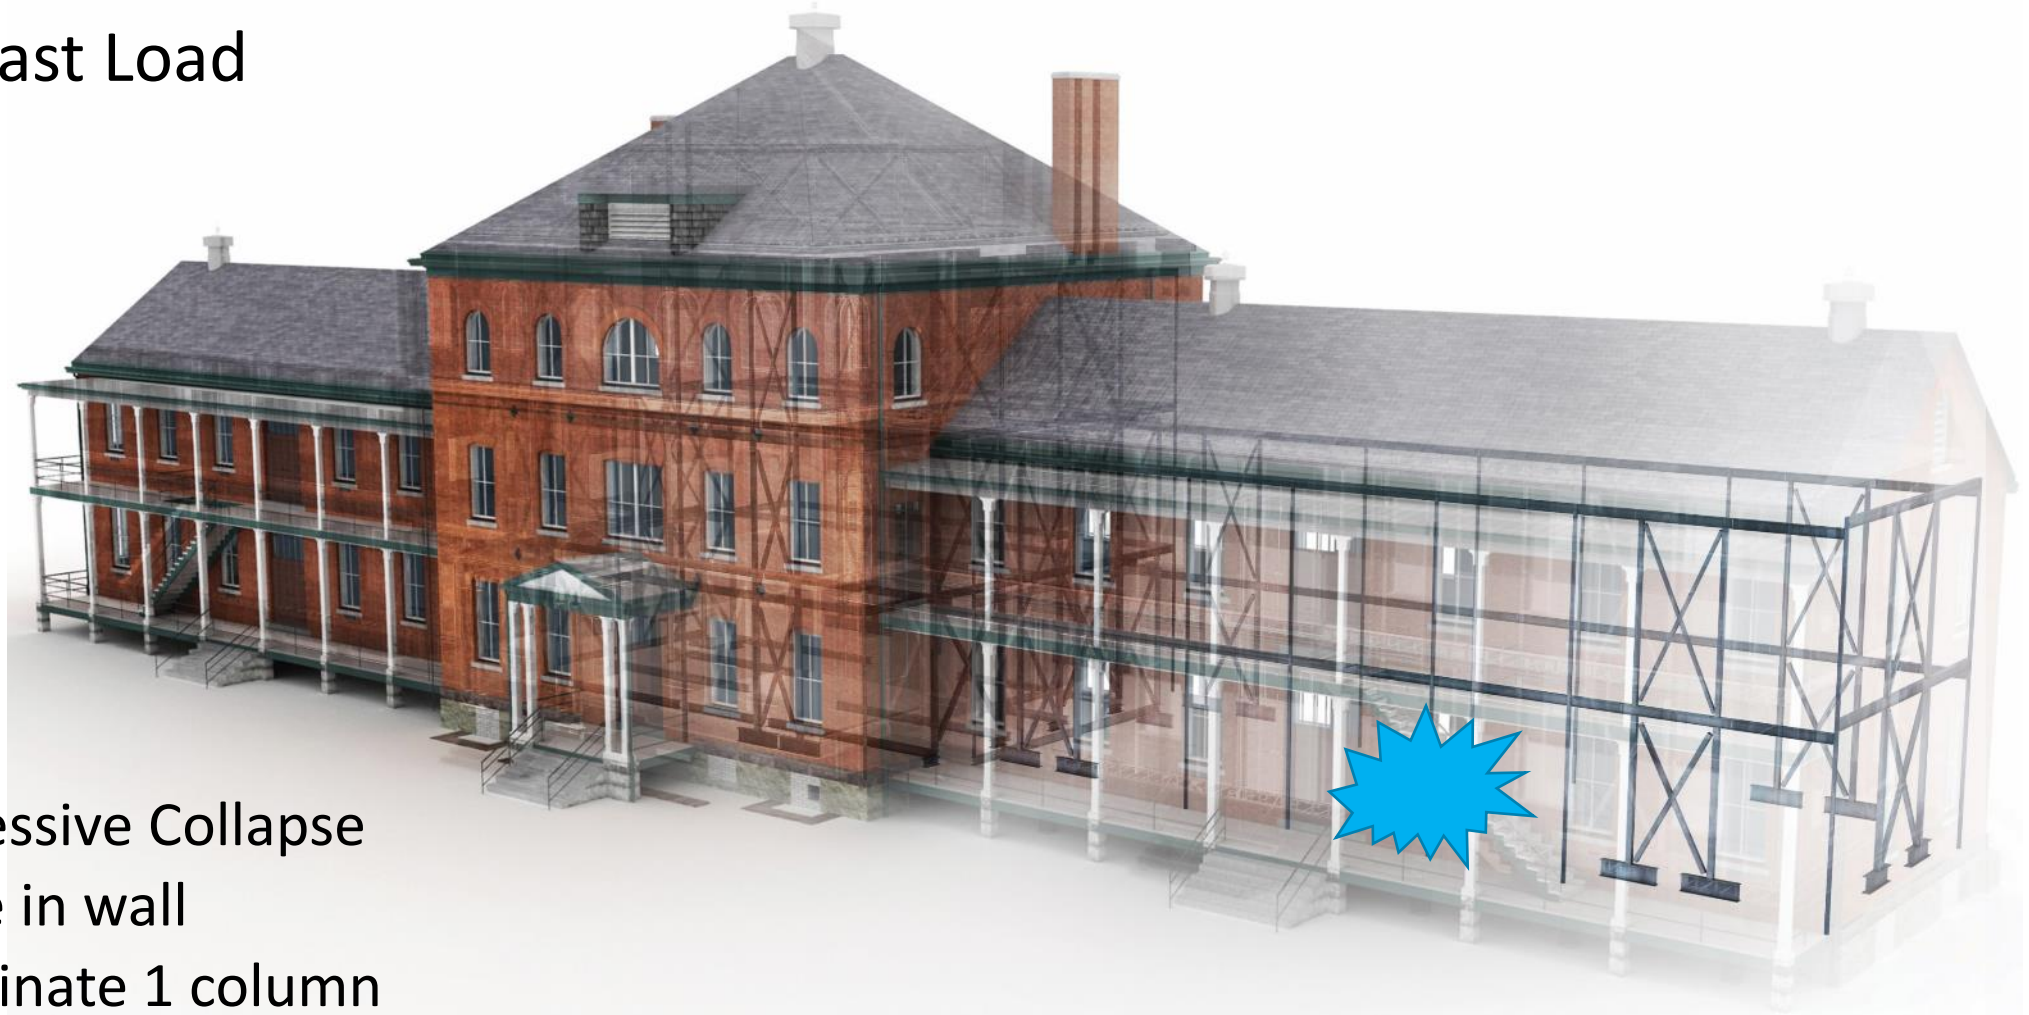
Retrofit - Endoskeleton

- Blast Load

Progressive Collapse

- Hole in wall
- Eliminate 1 column

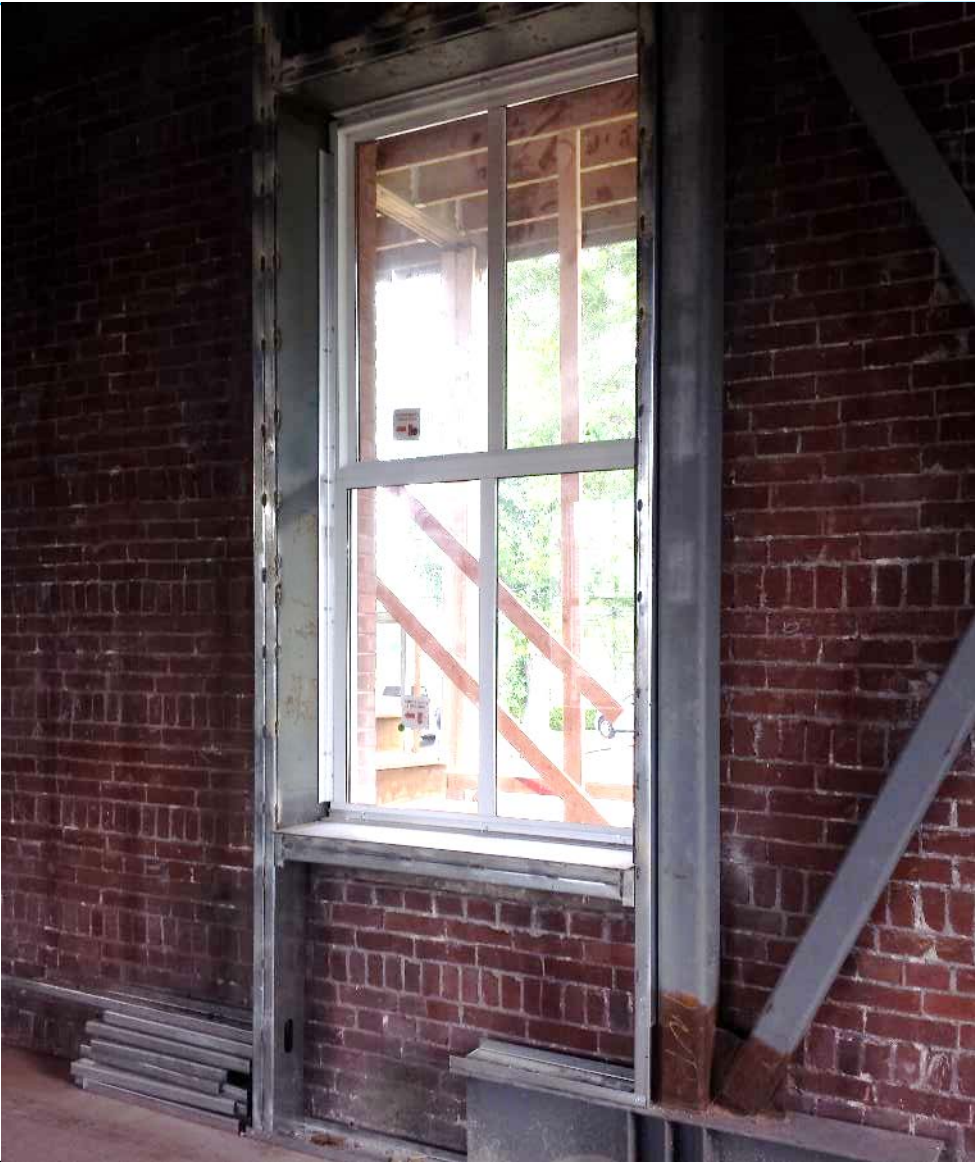
Retrofit - ATFP Windows

- 33 ft standoff
- Moderate blast load
- Massive walls
- Brittle walls
- Reinforcing required, but light reinforcing ok

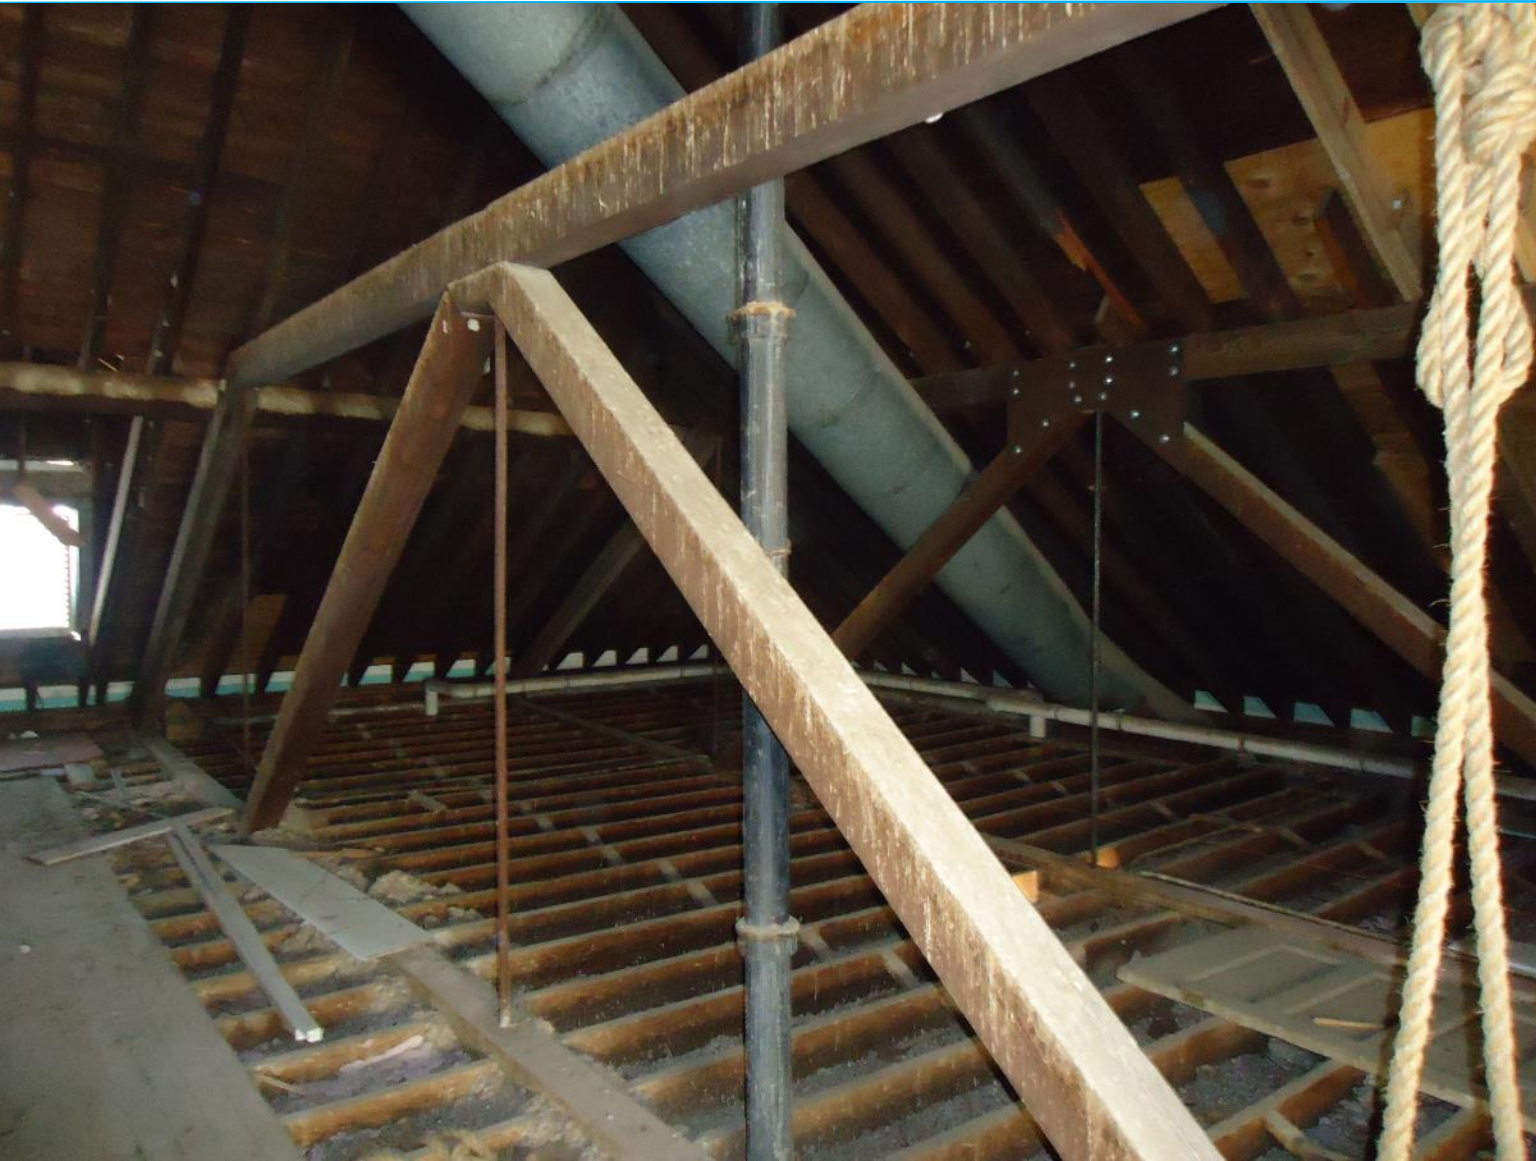
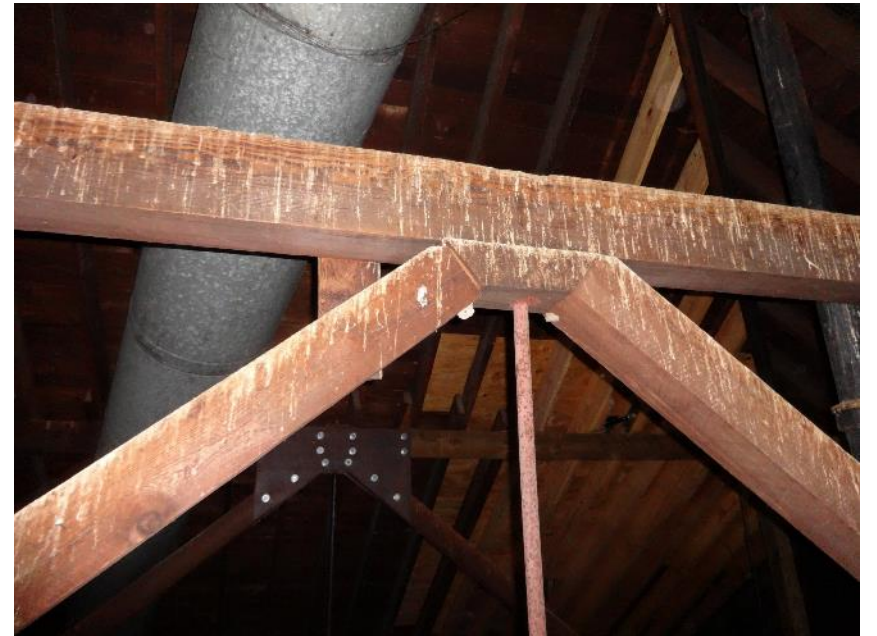
Retrofit - Roof Trusses

- Tension only rods
- Friction connections
- Unbraced top chord
