Maintaining the Balance: Security and Sustainability

A Case Study in Government LEED Certified Design

Jennifer R. Olson, AIA ♦ Architect

Case Study: Building 403 Administration Facility

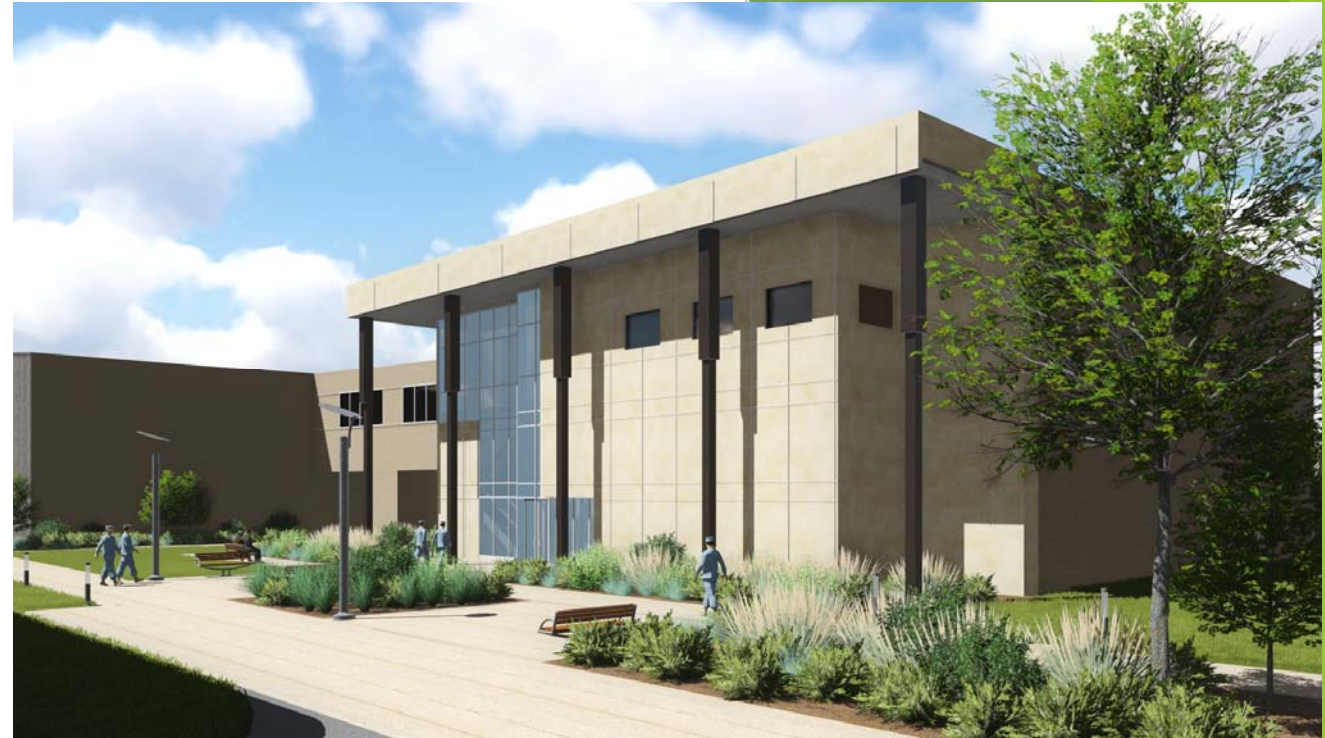
Rendering of Main Entrance to Building 403 demonstrating campus architecture compatibility

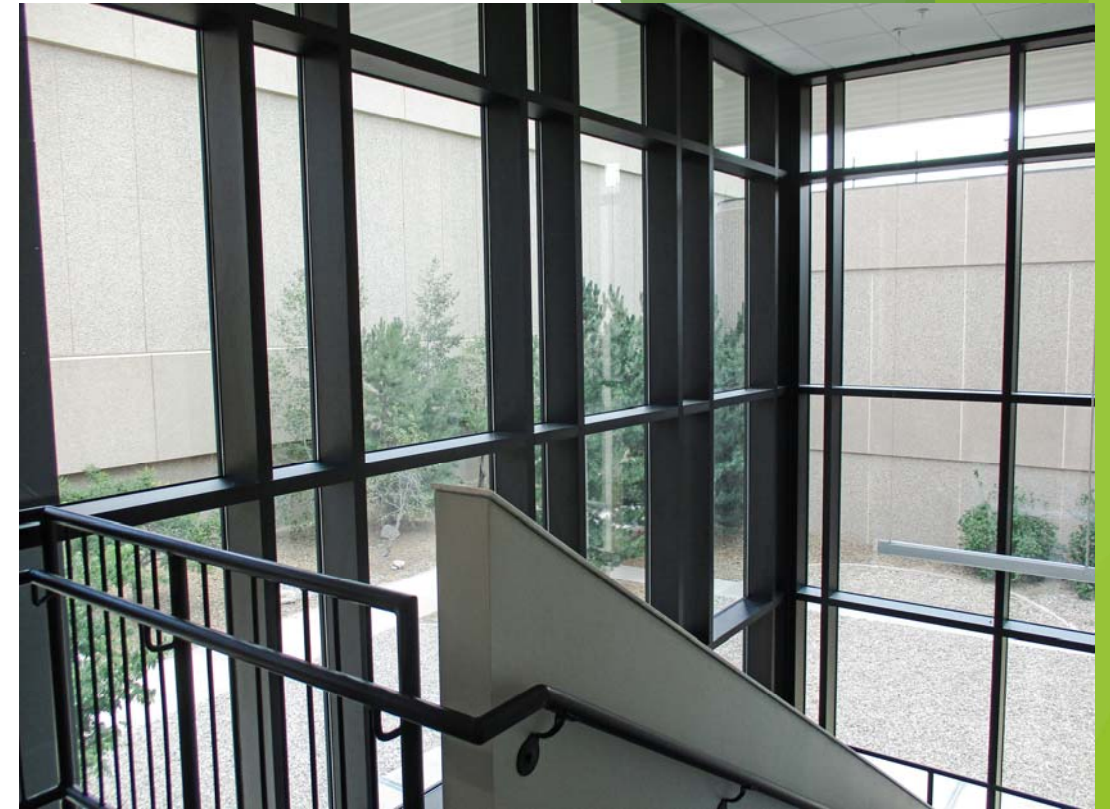
Two-Story glass curtainwall at main entrance on East Façade

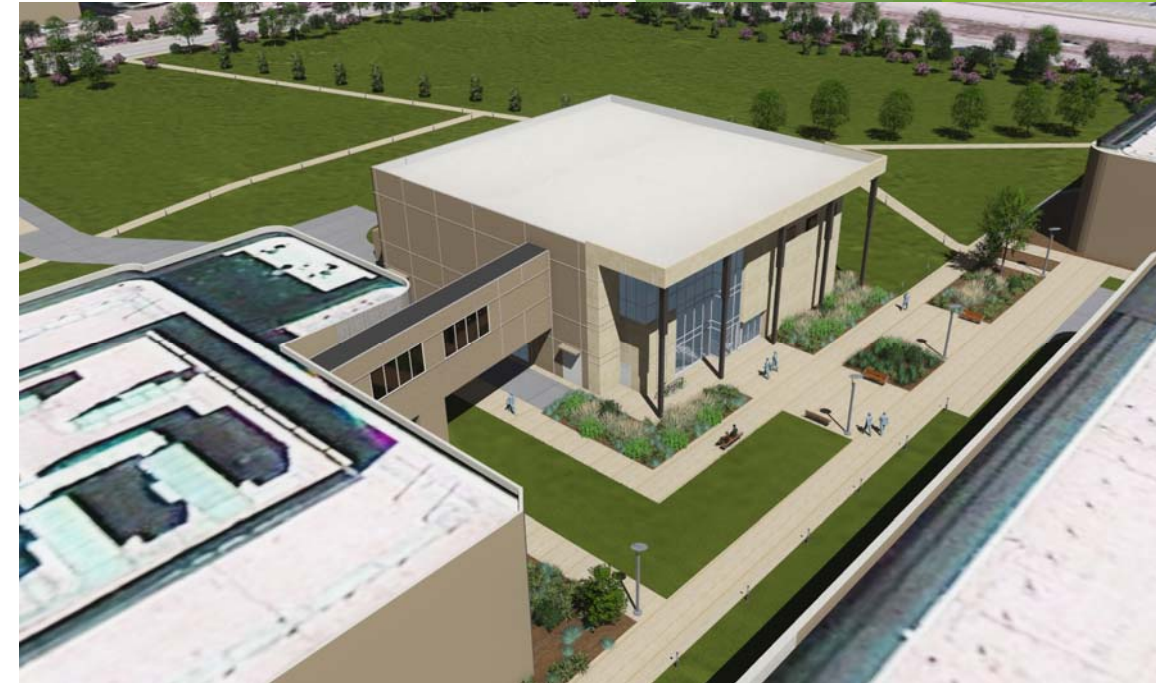
Aerial rendering of Building 403, secure elevated walkway, and existing Building 401

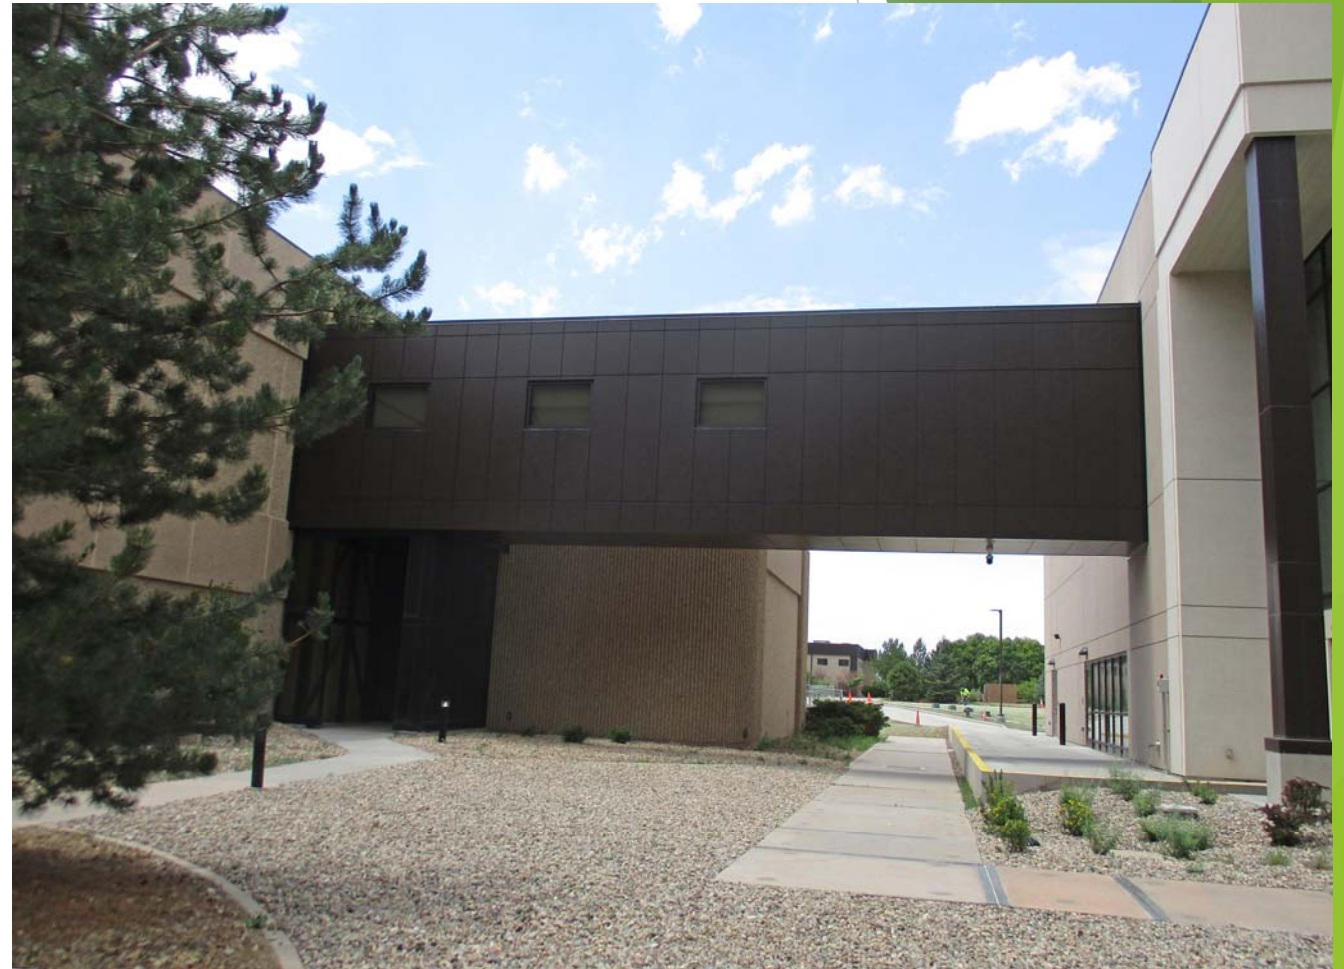
Secure elevated walkway connecting new Building 403 to existing Building 401 improves efficiency

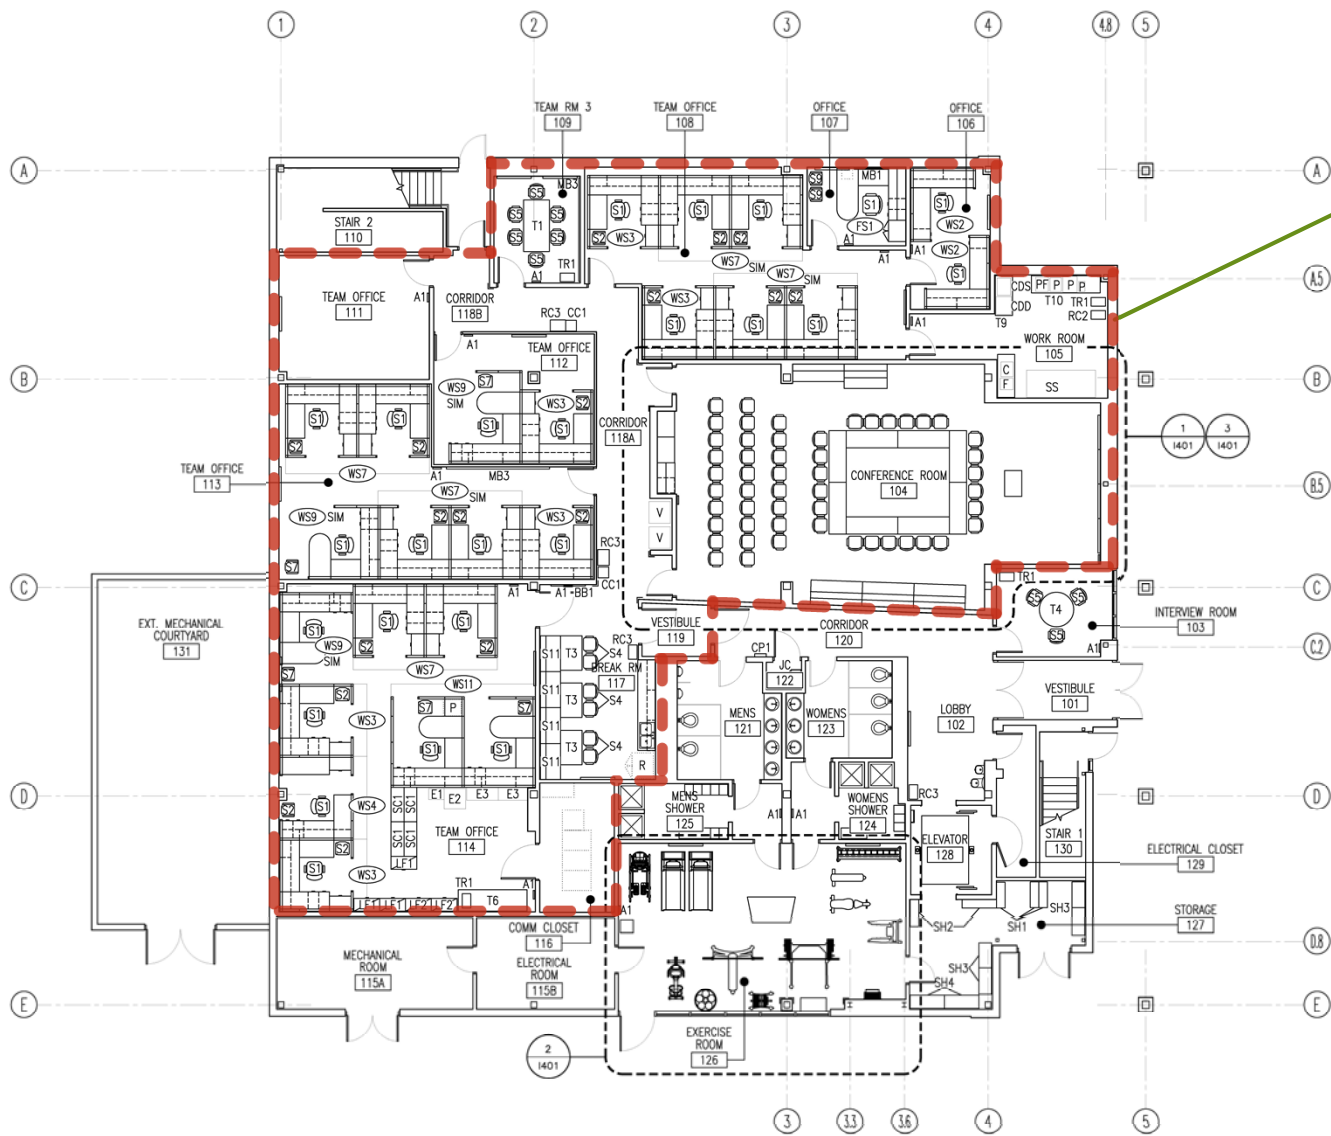
Case Study: Building 403 Administration Facility Floor Plan - First Floor

Zone 1
Secure Perimeter

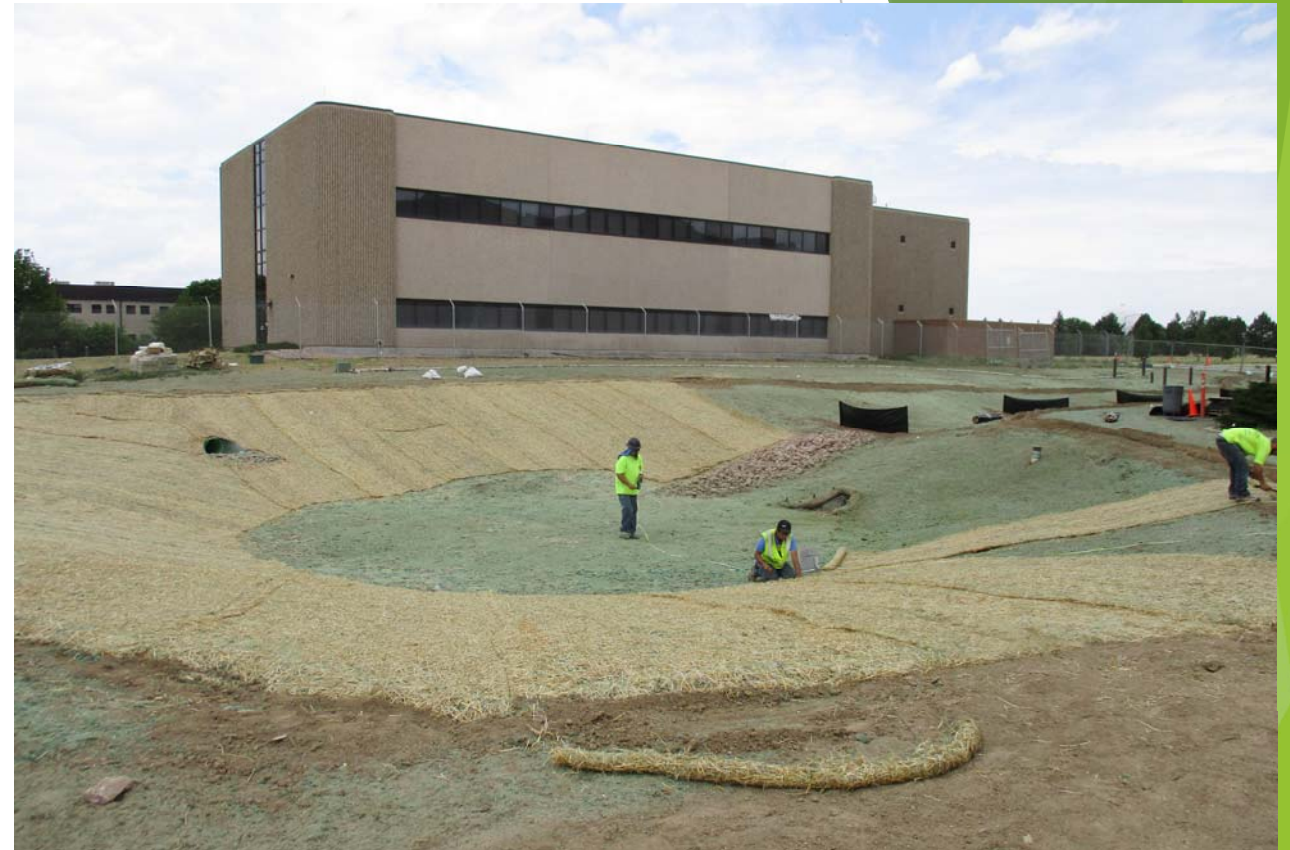
Sand Filter Extended Detention Basin
Retained the entire volume of the 1-year and 2-year post-development runoff, reducing the peak runoff from those events to zero.

- Stormwater quality and quantity control was a difficult credit to achieve
 - AT/FP requirements limited the possible choices for detention
 - Limited site area to provide a large basin
 - Utilized a sand filter detention basin and grass swales to obtain zero post-development discharge and remove all total suspended solids.
- Light Pollution concerns
 - Pedestrian campus environment with numerous walkways surrounding the site
 - High Security Area
- Daylighting and Views - not compatible with the secure area requirements
 - First floor could not have any windows within the secure perimeter
- Design flexibility for a changing force and mission
 - Full height demountable partitions
 - 28" raised access flooring throughout the secure areas
 - Provided an opportunity for an Innovation Design credit

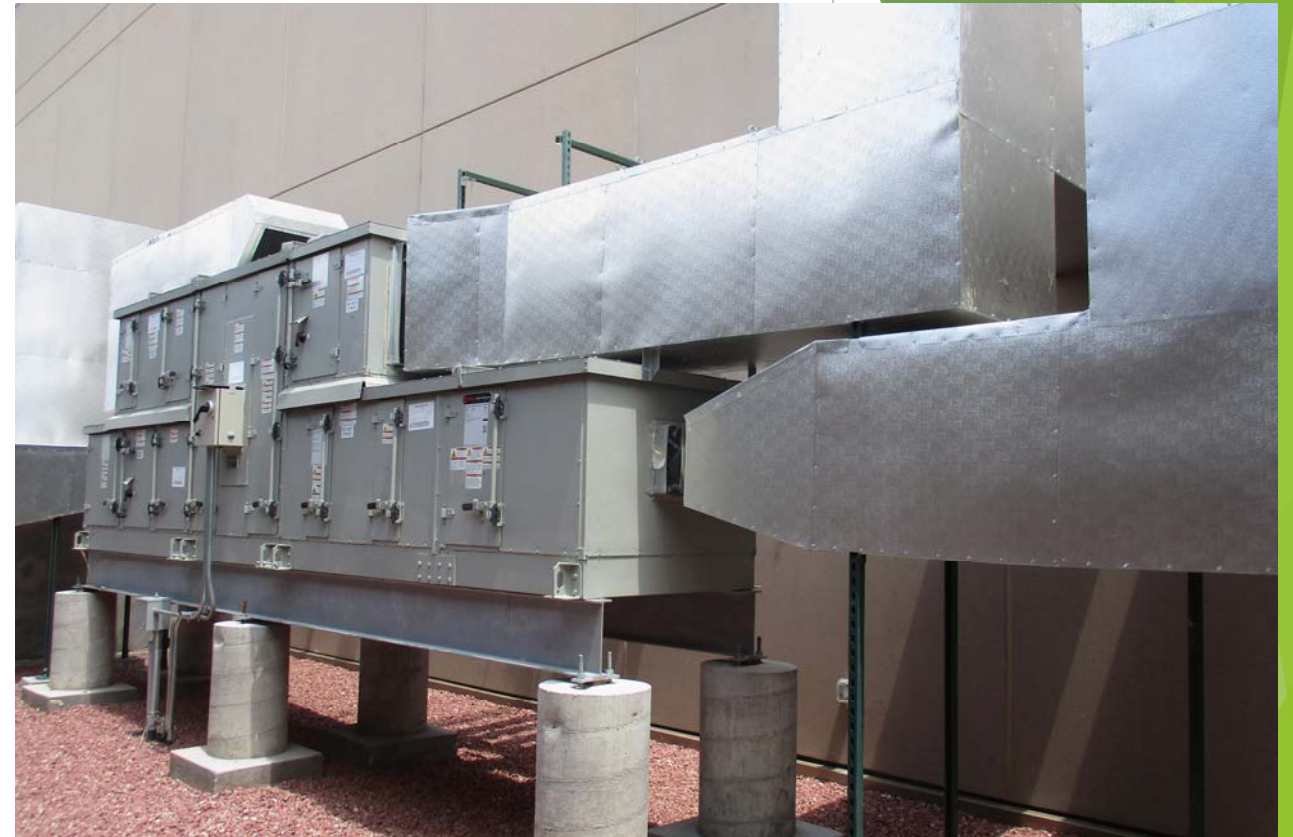
Exterior mechanical yard with air handling unit, placement provides excellent clearance for maintenance

- AT/FP Requirements also affected plant selection
- Energy Efficient Mechanical Design
 - ECM Motors with built-in inverter and magnet rotors provided greater efficiency and long-term energy savings.

- On-base central plant with free cooling technology generated low-cost chilled water in winter.
 - Dedicated outdoor air system with fan coil units were used to more efficiently satisfy the 100% outside air requirement

- FCUs modulating and cycling individually with the load, resulted in significantly less fan energy
- The Heavy Repairs Shop on base was able to accept 30,000 lbs of reinforced concrete pipe, diverting the waste from local landfills
