Foundation Design Challenges & Solutions in the Arctic & Subarctic

EIE376 & EIE379 Eielson
F35 Hangars

Galena Fire Hall Replacement

Cape Lisburne Water Storage Tanks

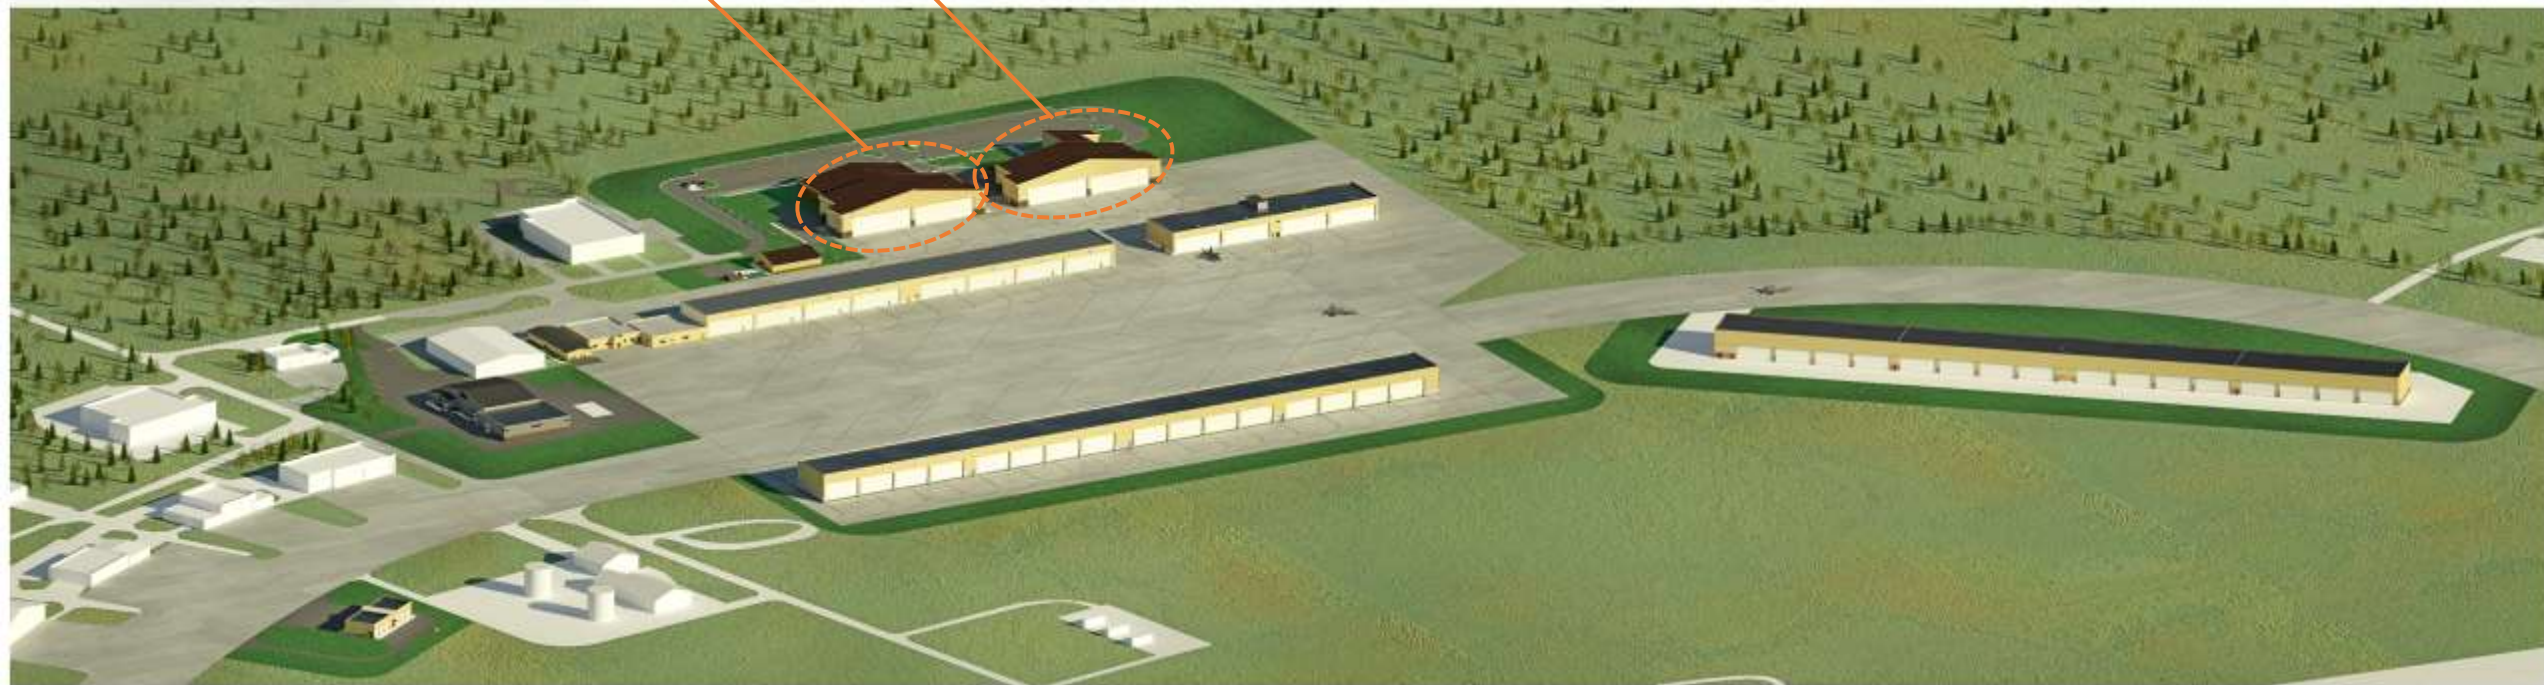
- Active and previously developed apron areas
- Discontinuous permafrost soils
- Unfrozen soils present liquefaction hazard

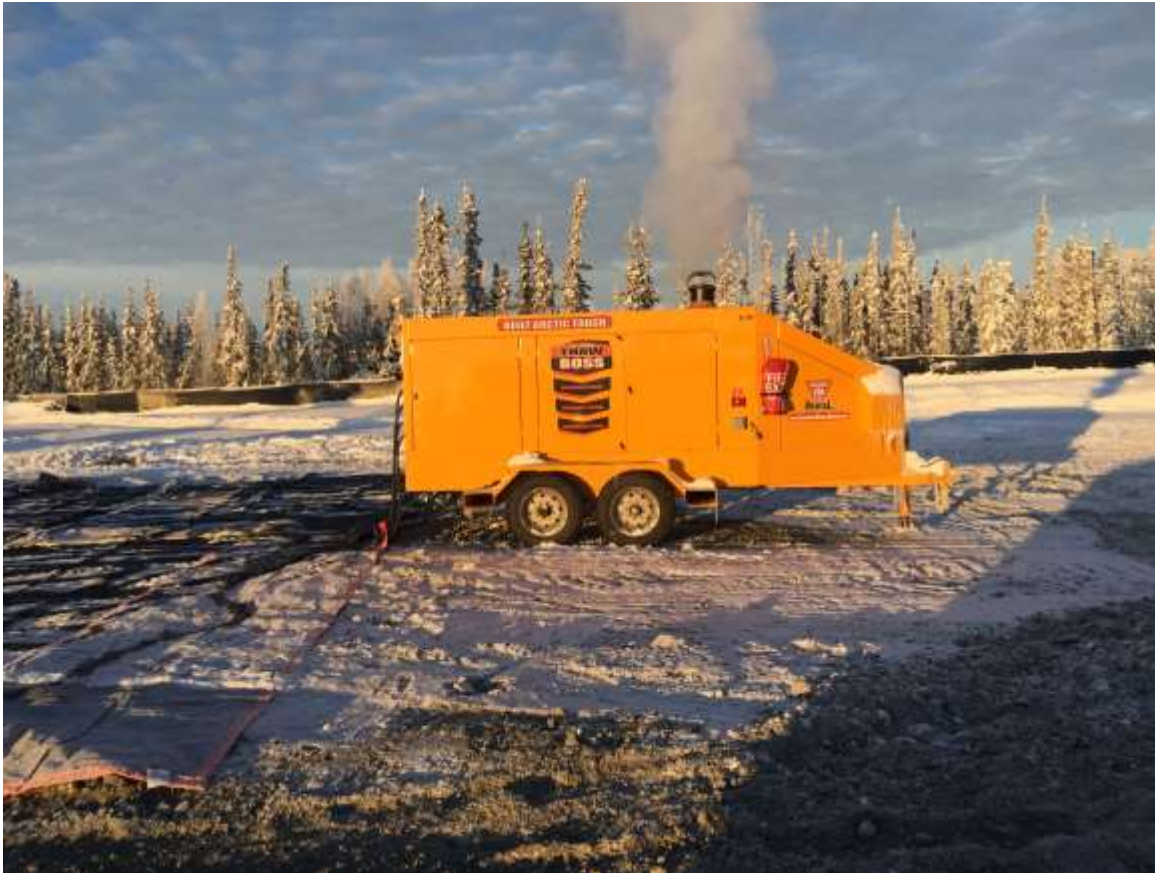
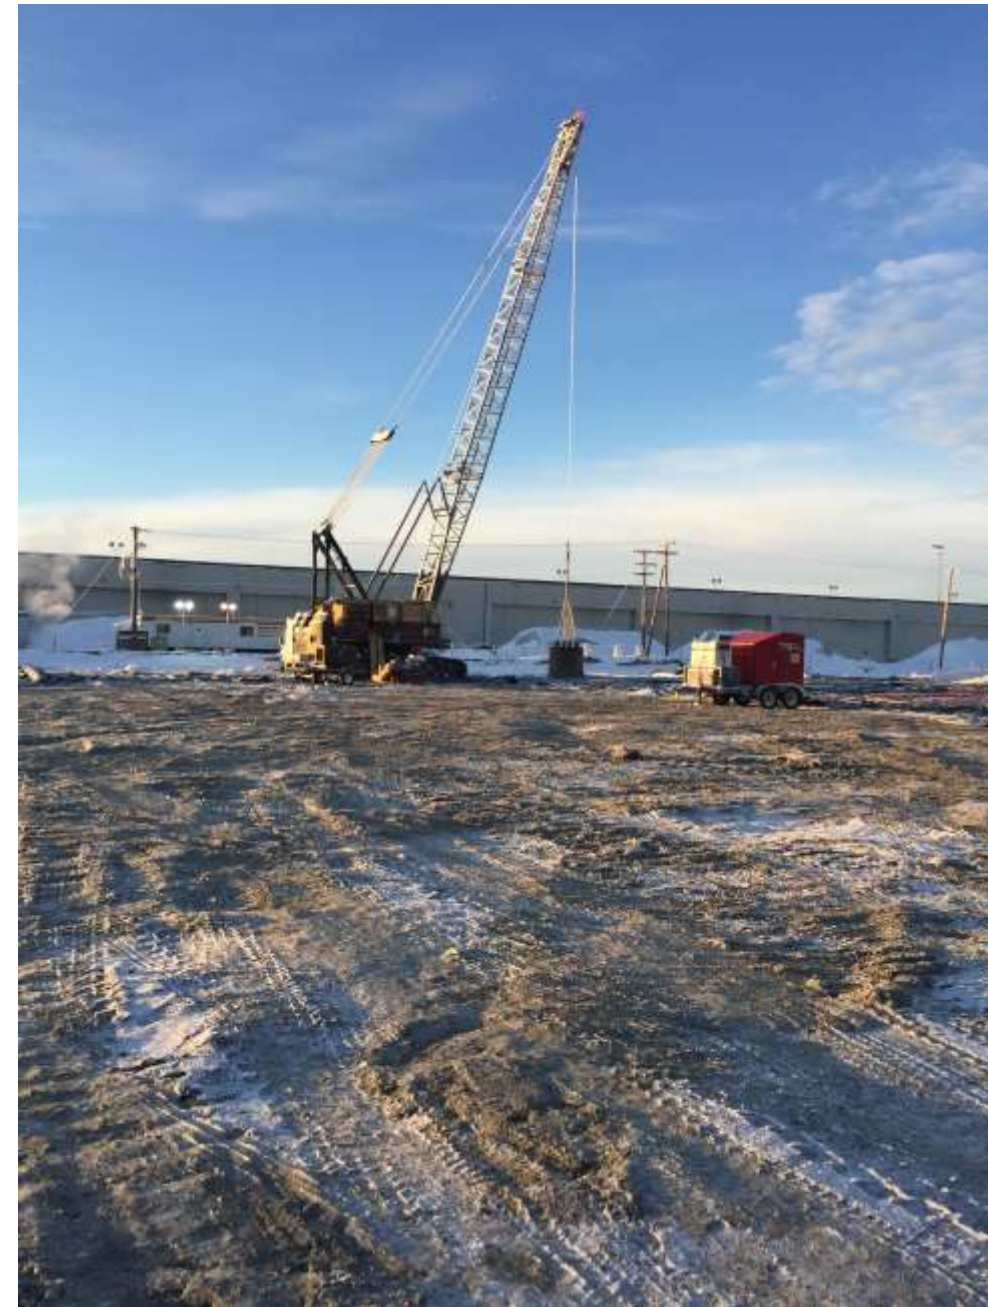
Ground Improvement Measures

- Thawing
- Deep Dynamic Compaction (DDC)

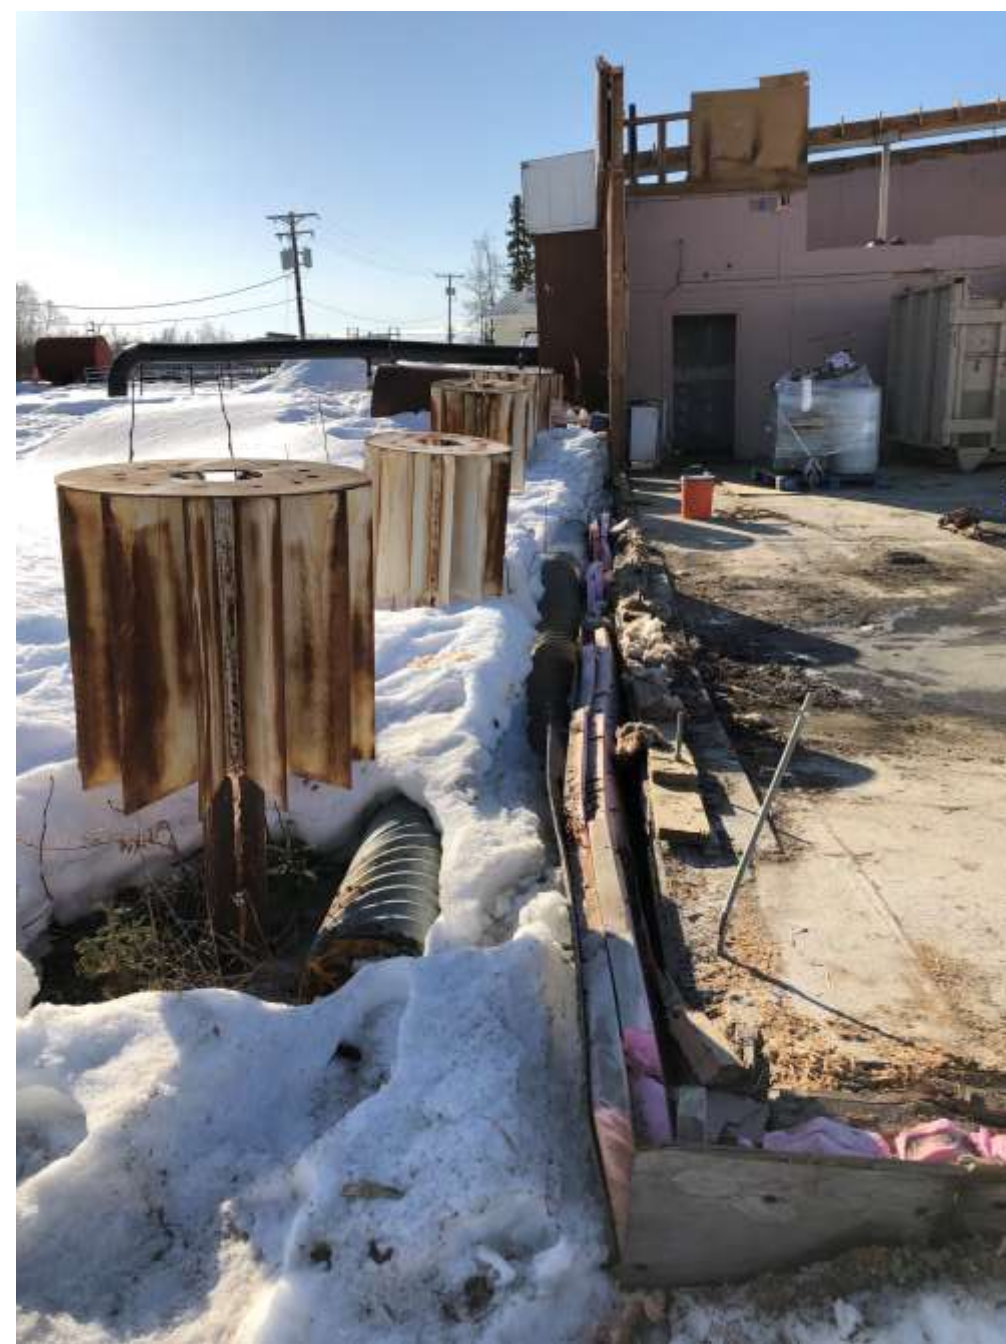
Existing foundation

- Old school thermosyphons
- Flat loop cooled pad
- Severe differential settlement
- Poor maintenance on system

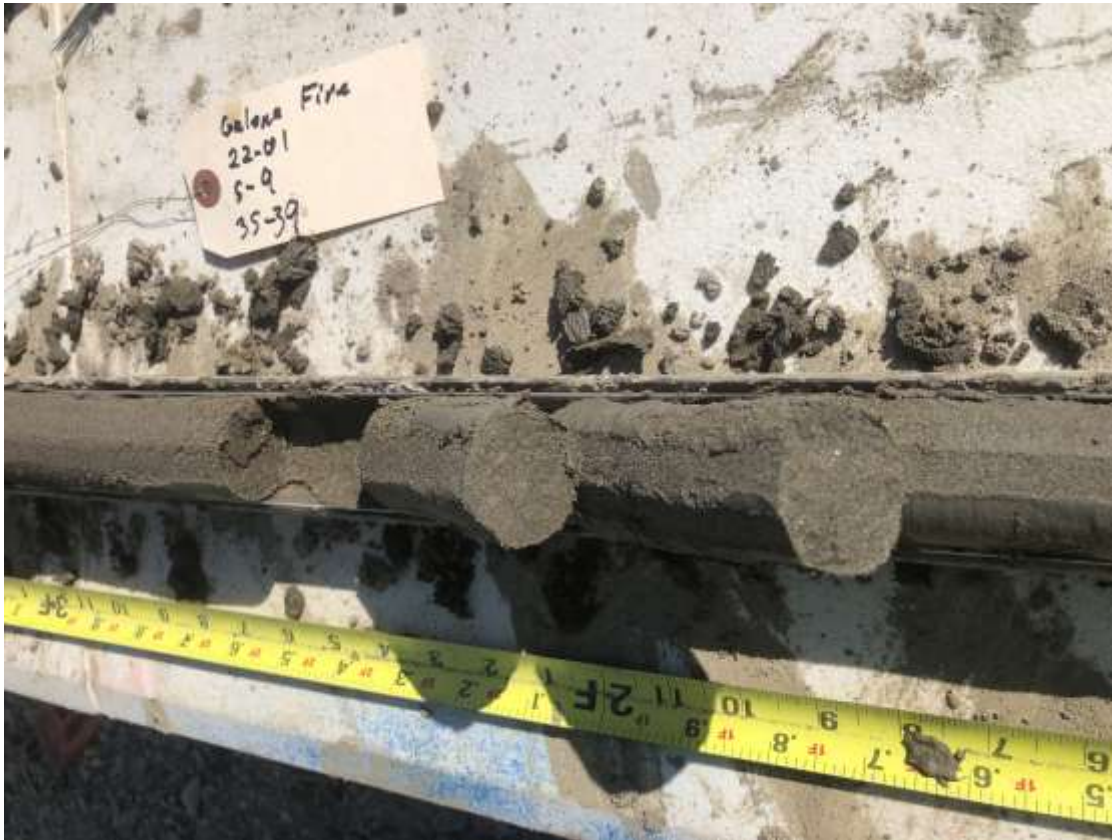
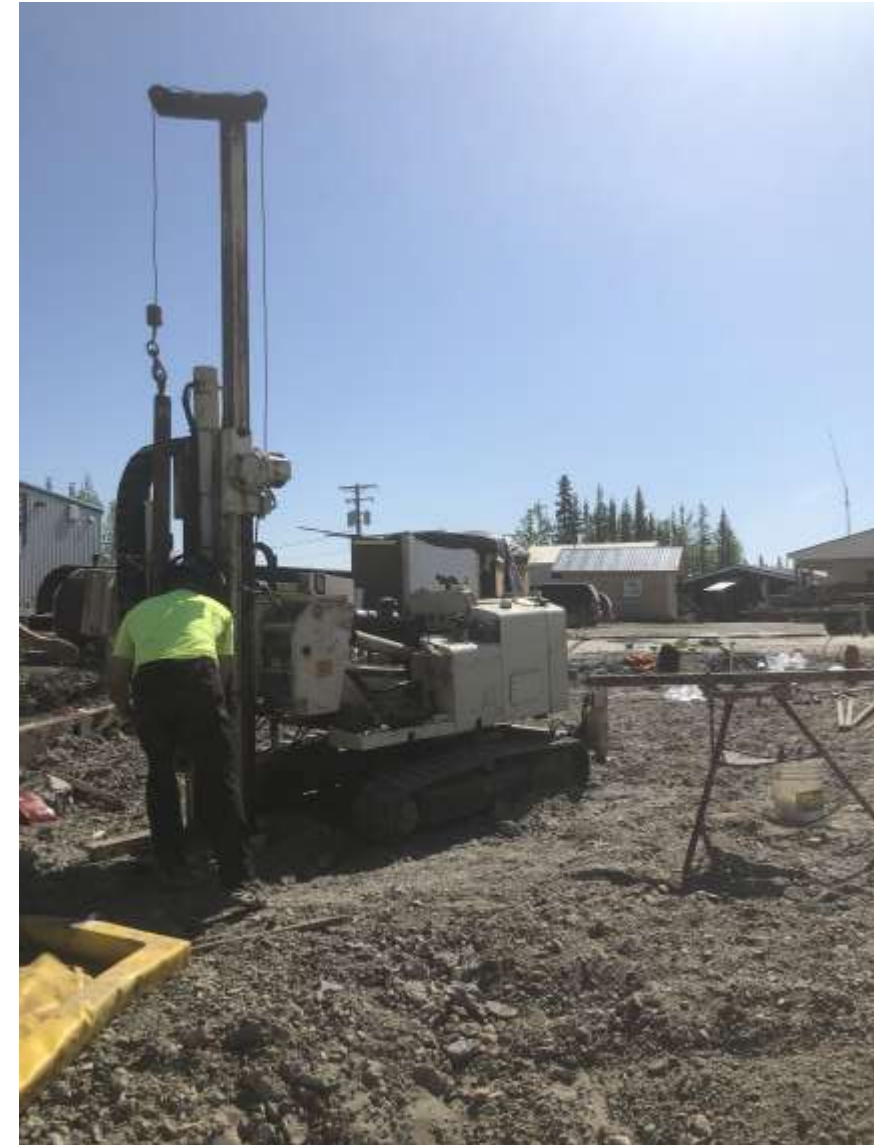
Soil Characterization

- Geotechnical borings
- Ground temperature measurements
- Lab testing

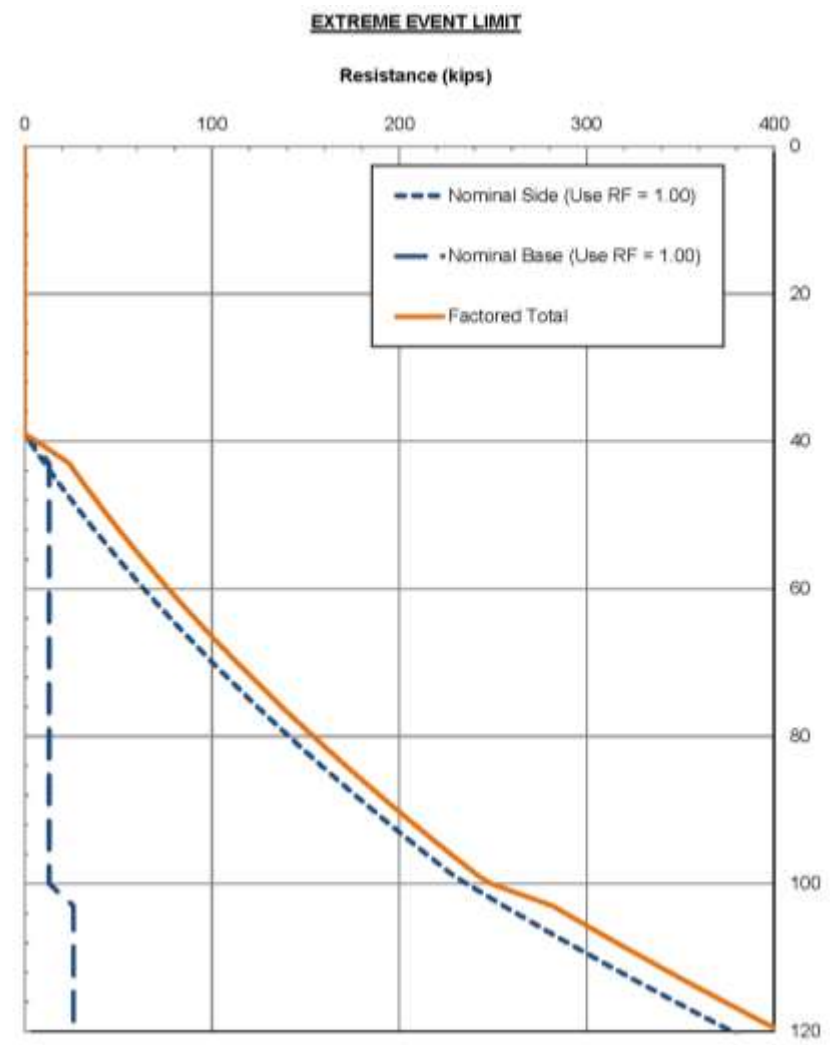
Approximate Subsurface Profile
(Based on Boring 22-01)

Pile Foundations - Assumed eventual ground thawing and account for downdrag

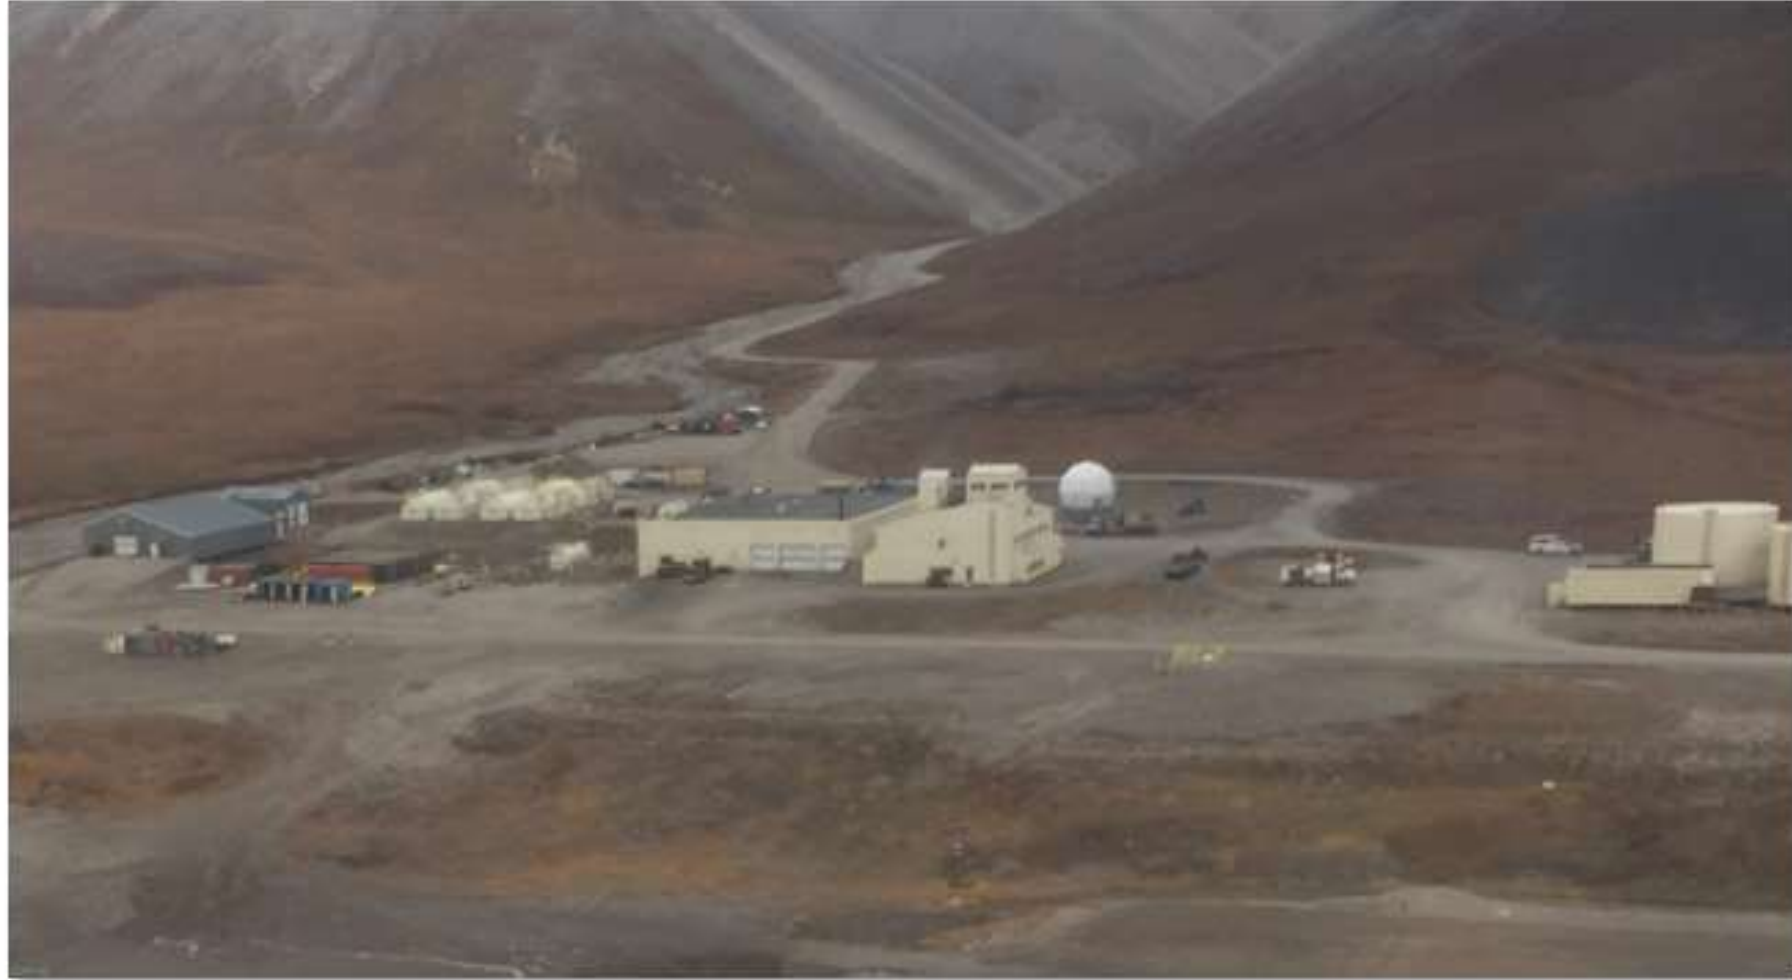
Water Tank Replacement

- Existing tanks constructed in the 1970s
- Conventional isolated footings
- Settlement issues along with spalling concrete
