Emergency Response: RxR Bridge Collapse Brunswick, MO

- Owner: Norfolk Southern RxR
- Prime: Hanson Professional Services
- Sub: Prairie Engineers, P.C.

October 1, 2019 highwaters on the Grand River have formed a large log jam upstream of the RxR bridge, it's 267' long consisting of eight spans. The hydraulic forces applied on the bridge are resulting in structural deformation to the structure.

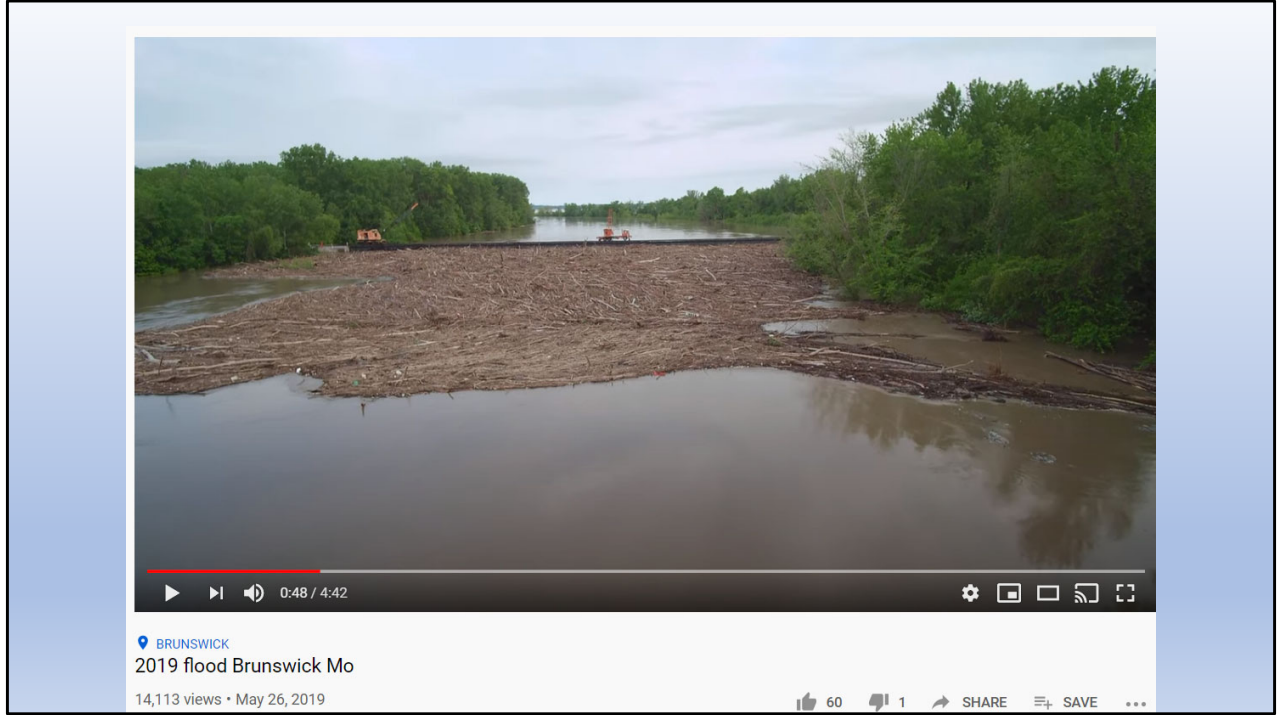
The RxR bridge normally has 5-7 feet of clearance above the river

In May 2019 - spring rain events carried large amounts of timber down stream on the grand river, creating a log jam at the RxR bridge

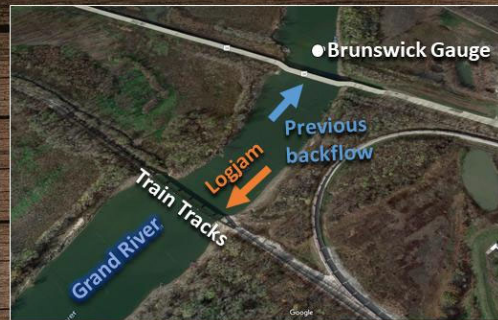
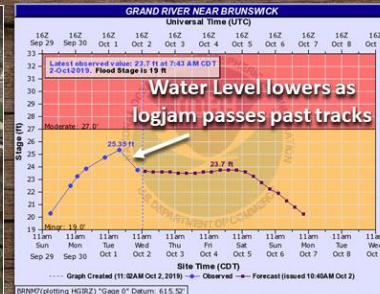
Train Track Collapse Lowers Brunswick

- Backwater from debris caused Brunswick gauge to rise
- Logjam collapsed train tracks 10/1/2019
- As the logjam moved past tracks, significant drop in backwater at the upstream gauge

The log jam at the bridge was holding back over two feet of water, the upstream gauge on the 24 Hwy bridge recorded the rapid water level drop
