WEBBERS FALLS RECENT PROJECTS AND SCOUR REPAIR

SAME Meeting September 18, 2025

Webbers Falls, OK.

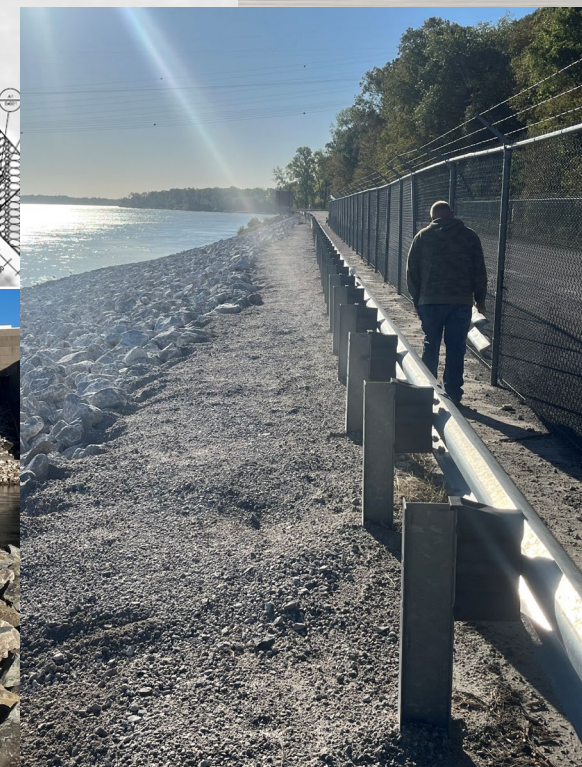
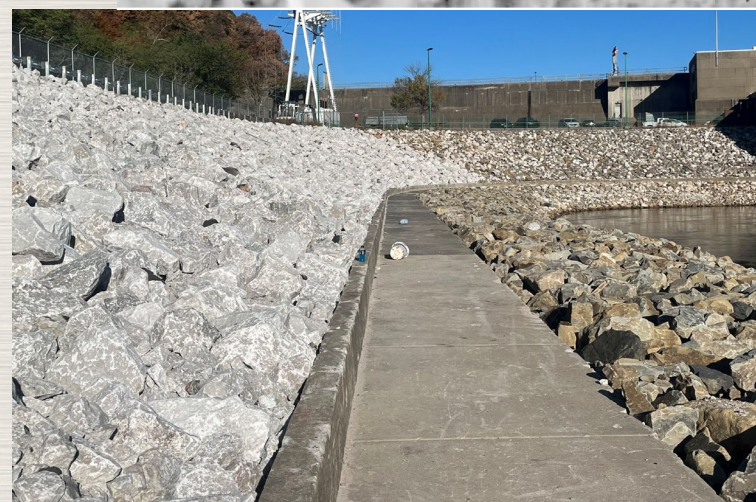
Existing riprap and subgrade was washed downstream, significant damage to powerhouse access road

Remove and replace damaged guardrail and fencing
