BIANNUAL RESILIENCY WORKSHOP • 2025

ENHANCING COASTAL RESILIENCE AT JEAN LAFITTE NATIONAL HISTORICAL PARK AND PRESERVE: A NATURE-BASED BREAKWATER SOLUTION

RYAN LEE WALDRON, P.E., BC.CE

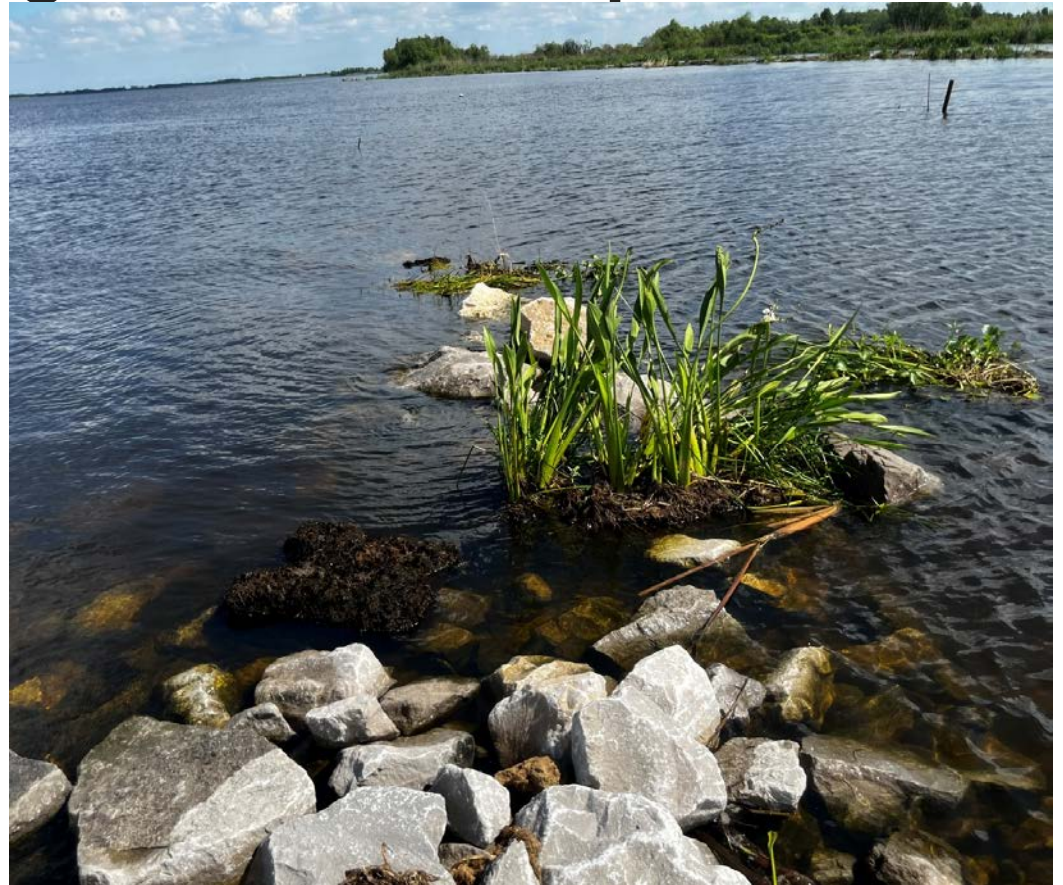
- Immediately upon placement, the northernmost 75' of breakwater settled several feet in a single event.
- Bathymetry after Ida showed a scour hole between the end of the USACE breakwater and the beginning this one.
- Armor stone slid into the hole.
- An additional ~112 CY of Armor Stone

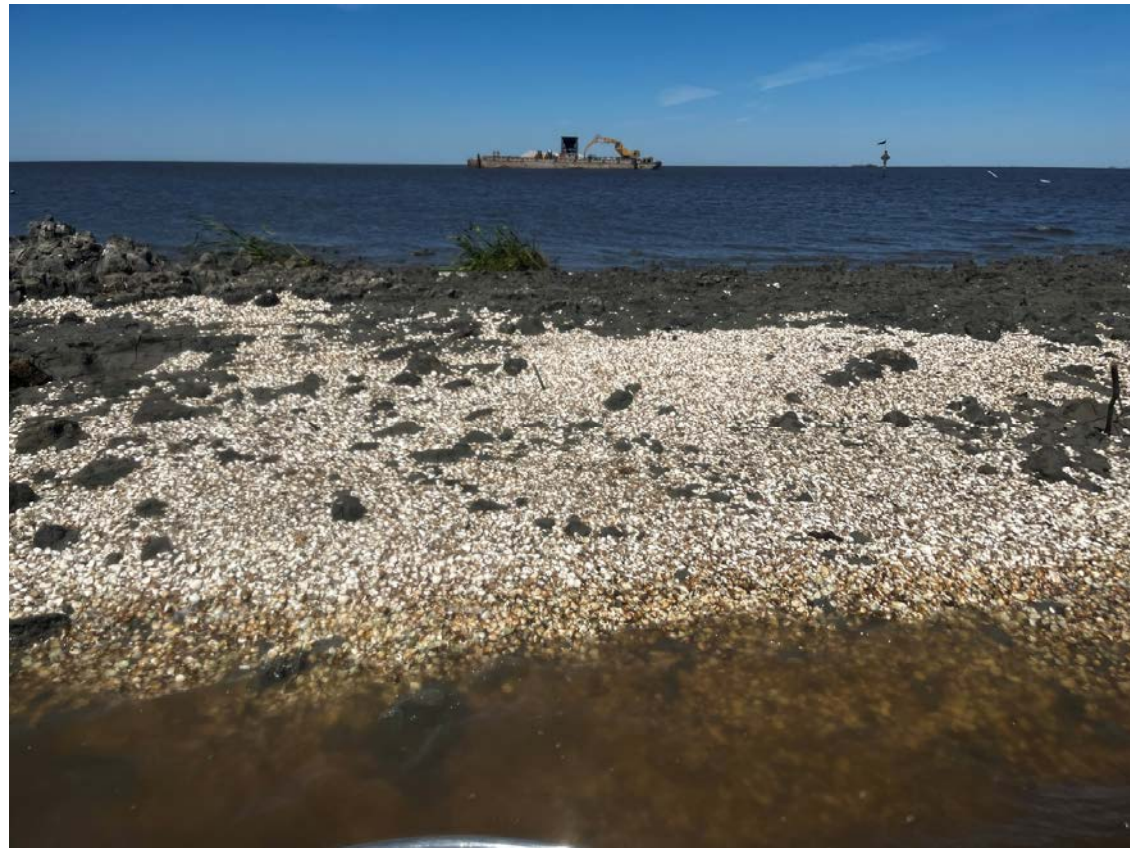
- Flotation access channel spoils contained shells
- Cultural Resources or Natural?
- An abundance of Rangia Clam (*Rangia Cuneata*) on the bed of Lake Salvador
- Already disturbed, and being returned.
- Progress as planned.
